Access Compliance Report

Public Rights-of-Way

(Curb Ramps)

Intersection ID: 30548	Main Street: CAROLINA_PAVILION_DR	Cross Street: SOUTH_BV	Location: SW
ADA ID: 1BA060B34B69	Ramp Type: Perp	Initial Pass/Fail: Fail	Overall Compliance: No
Severity Score: 33.75			
Codes/Mitigation Info/Possible Solution		Field Measurements/Component Compliance

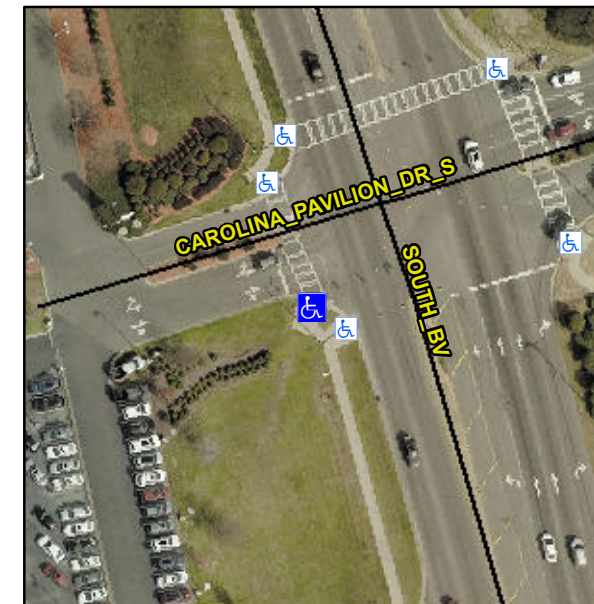
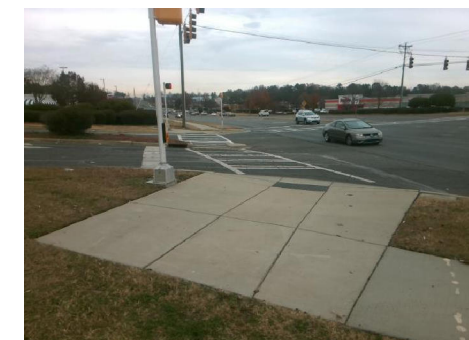
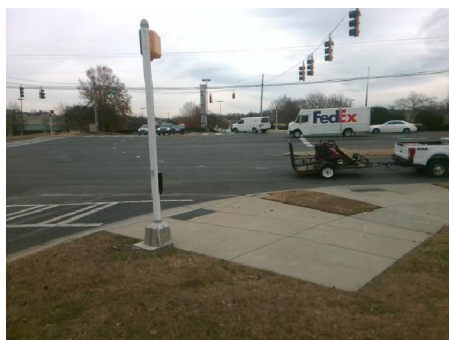
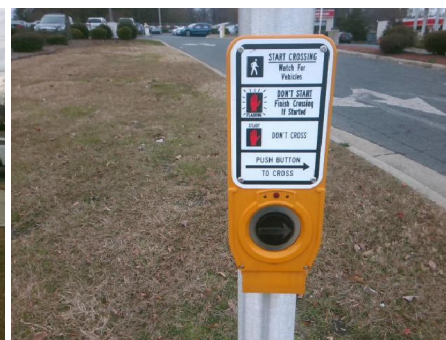
Not Found, R304.5.1, R304.5.3

Compliance	Description	Data	Compliance	Description	Data
N/A	Ramp Length (in)	134.0	Yes	Ramp Slope (%)	7.5
No	Ramp Width (in)	45.0	No	Ramp XSlope (%)	7.0
N/A	Flare Type LT	N/A	N/A	Flare Type RT	N/A
N/A	Flare Slope LT (%)	N/A	N/A	Flare Slope RT (%)	N/A
N/A	Flare Traversable LT?	N/A	N/A	Flare Traversable RT?	N/A
N/A	Landing Length (in)	N/A	N/A	DWS Provided?	N/A
N/A	Landing Width (in)	N/A	N/A	DWS Contrast?	N/A
N/A	Landing Slope (%)	N/A	N/A	DWS Length (in)	N/A
N/A	Landing X Slope (%)	N/A	N/A	DWS Full Width?	N/A
N/A	Landing Curb? (Y/N)	N/A	N/A	DWS Offset (in)	N/A
N/A	Shared Landing?	N/A			
N/A	Gutter Ponding?	N/A	N/A	Gutter Slope (%)	N/A
N/A	Gutter Lip Ht (in)	N/A	N/A	Gutter X Slope (%)	N/A
N/A	Painted X Walk1?	Yes	N/A	Painted X Walk2?	N/A
	X Walk 1 Direction	To N		X Walk 2 Direction	N/A
N/A	X Walk 1 Width (in)	106.0	N/A	X Walk 2 Width (in)	N/A
	X Walk 1 Slope (%)	1.3		X Walk 2 Slope (%)	N/A
	X Walk 1 X Slope (%)	5.3		X Walk 2 X Slope (%)	N/A

N/A	Ramp inside XWalk1?	Yes	N/A	Ramp inside XWalk2?	N/A
	Road Slope (%)	N/A	N/A	Clear Space?	N/A
	Road X Slope (%)	N/A	N/A	Clear Space to XWalk (in)	N/A
N/A	Any Obstructions?	N/A	N/A	Storm Grate/Utility Hazard?	N/A
	Obstruction Type			Storm Grate/Utility Type	
		N/A			N/A
		Yes		Surface Condition? (G/P)	Good

Remove & Replace Entire Ramp.

Total Cost: \$ 1850.00
