Access Compliance Report Public Rights-of-Way (Curb Ramps)

Intersection ID: 4672 Main Street: W_MALLARD_CREEK_CHURCIERSS Street: SENATOR_ROYALL_DR Location: NW **ADA ID: 1BB4C670BC4D** Ramp Type: Perp Initial Pass/Fail: Fail **Overall Compliance: No Severity Score:** 25

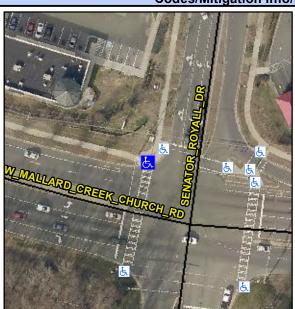
/Possible Solution Field Measurements/Component Complia					Compliance
Possible Solutions:	Comp	oliance Description	Data	Compliance	Description
Remove & Replace Entire Ramp.	N/A	Ramp Length (in)	102.0	No Ran	np Slope (%)
· ·	Yes	Ramp Width (in)	48.0	Yes Ran	np XSlope (%)
	N/A	Flare Type LT	N/A	N/A Flar	e Type RT
	N/A	Flare Slope LT (%)	N/A	N/A Flar	e Slope RT (%)
	N/A	Flare Traversable LT?	N/A	N/A Flar	e Traversable RT?
	N/A	Landing Length (in)	N/A	N/A DW	S Provided?
Surveyor Notes:	N/A	Landing Width (in)	N/A	N/A DW	S Contrast?
N/A	N/A	Landing Slope (%)	N/A	N/A DW	S Length (in)
	N/A	Landing X Slope (%)	N/A	N/A DW	S Full Width?
	N/A	Landing Curb? (Y/N)	N/A	N/A DW	S Offset (in)
	N/A	Shared Landing?	N/A		
PROW/ADA:	N/A	Gutter Ponding?	N/A	N/A Gut	ter Slope (%)
R304.2.2	N/A	Gutter Lip Ht (in)	N/A	N/A Gut	ter X Slope (%)
	N/A	Painted X Walk1?	Yes	N/A Pair	nted X Walk2?
		X Walk 1 Direction	To SW	ΧW	alk 2 Direction

N/A	X Walk 1 Width (in)	104.0	N/A X W	/alk 2 Width (in)
		X Walk 1 Slope (%)	10.0	ΧW	/alk 2 Slope (%)
		X Walk 1 X Slope (%)	4.0	ΧW	/alk 2 X Slope (%)
	N/A	Ramp inside XWalk1?	Yes	N/A Rar	np inside XWalk2?
		Road Slope (%)	N/A	N/A Clea	ar Space?
		Road X Slope (%)	N/A	N/A Clea	ar Space to XWalk (in)
	N/A	Any Obstructions?	N/A	N/A Sto	m Grate/Utility Hazard?
Total Cost: \$ 1850.00)	Obstruction Type		Sto	m Grate/Utility Type
			N/A
