# Access Compliance Report

## Public Rights-of-Way

### (Curb Ramps)

Intersection ID: 24751	Main Street: CINNAMON_FIELD_RD	Cross Street: WILD_HEATHER_CT	Location: SW
ADA ID: 1BBAF82ED982	Ramp Type: Perp	Initial Pass/Fail: Fail	Overall Compliance: No Severity Score: 13.75

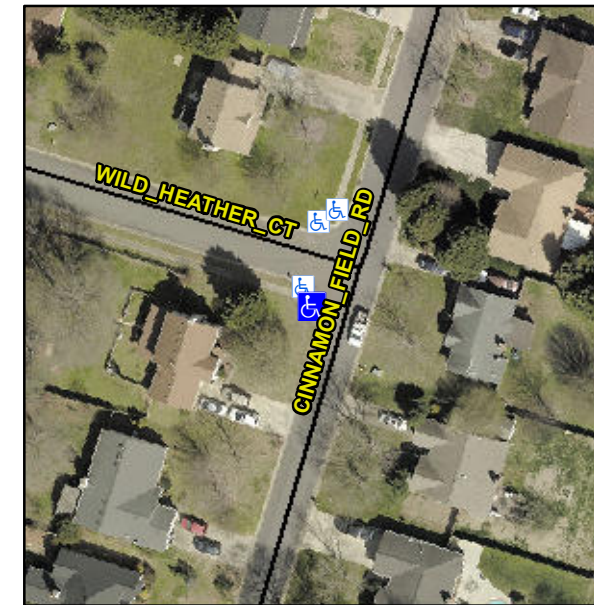
Compliance	Description	Data	Compliance	Description	Data
N/A	Ramp Length (in)	50.0	No	Ramp Slope (%)	10.1
Yes	Ramp Width (in)	60.0	Yes	Ramp XSlope (%)	2.8
N/A	Flare Type LT	N/A	N/A	Flare Type RT	N/A
N/A	Flare Slope LT (%)	N/A	N/A	Flare Slope RT (%)	N/A
N/A	Flare Traversable LT?	N/A	N/A	Flare Traversable RT?	N/A
N/A	Landing Length (in)	N/A	N/A	DWS Provided?	N/A
N/A	Landing Width (in)	N/A	N/A	DWS Contrast?	N/A
N/A	Landing Slope (%)	N/A	N/A	DWS Length (in)	N/A
N/A	Landing X Slope (%)	N/A	N/A	DWS Full Width?	N/A
N/A	Landing Curb? (Y/N)	N/A	N/A	DWS Offset (in)	N/A
N/A	Shared Landing?	N/A			
N/A	Gutter Ponding?	N/A	N/A	Gutter Slope (%)	N/A
N/A	Gutter Lip Ht (in)	N/A	N/A	Gutter X Slope (%)	N/A
N/A	Painted X Walk1?	No	N/A	Painted X Walk2?	N/A
	X Walk 1 Direction	To SE		X Walk 2 Direction	N/A
N/A	X Walk 1 Width (in)	N/A	N/A	X Walk 2 Width (in)	N/A
	X Walk 1 Slope (%)	0.7		X Walk 2 Slope (%)	N/A
	X Walk 1 X Slope (%)	3.7		X Walk 2 X Slope (%)	N/A

N/A	Ramp inside XWalk1?	N/A	N/A	Ramp inside XWalk2?	N/A
	Road Slope (%)	N/A	N/A	Clear Space?	N/A
	Road X Slope (%)	N/A	N/A	Clear Space to XWalk (in)	N/A
N/A	Any Obstructions?	N/A	N/A	Storm Grate/Utility Hazard?	N/A
	Obstruction Type			Storm Grate/Utility Type	
		N/A			N/A
			Yes	Surface Condition? (G/P)	Good

Possible Solutions:

**Remove & Replace Entire Ramp.**

**R304.2.2**

Total Cost:

**\$ 1850.00**
