# Access Compliance Report

## Public Rights-of-Way

### (Curb Ramps)

| Intersection ID: 48452 | Main Street: RED_RUST_LN | Cross Street: BURNT_LEATHER_LN | Location: NE |

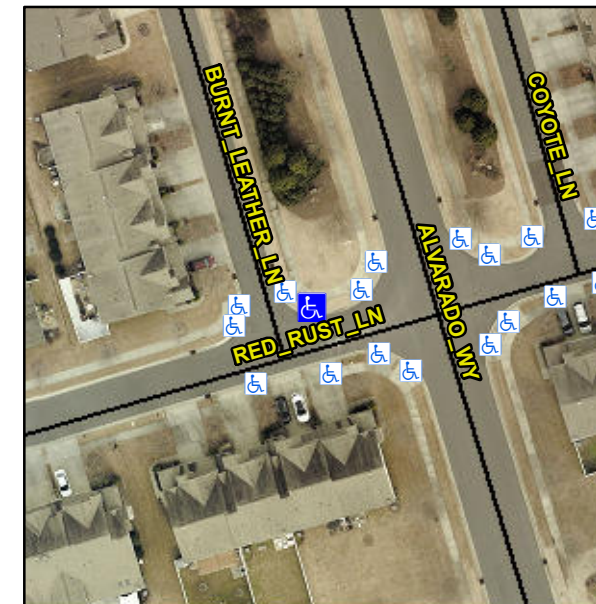
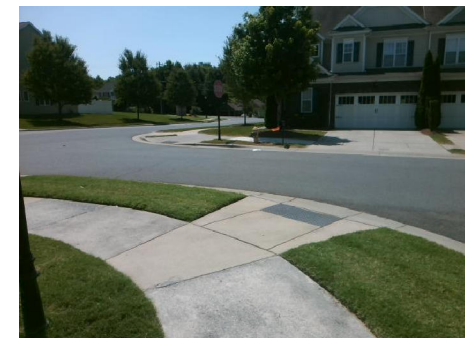
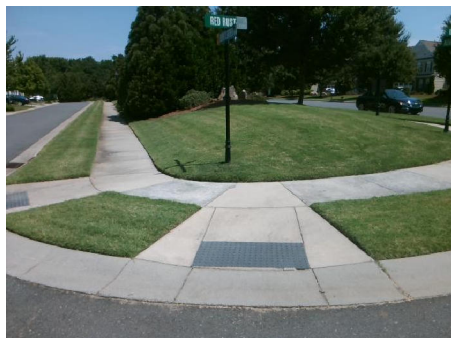
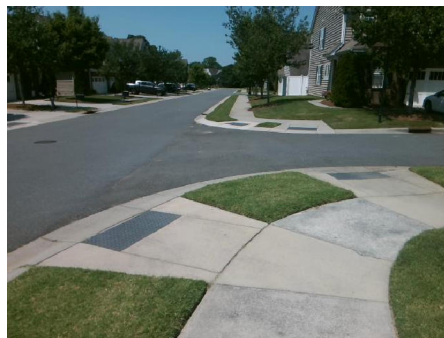
| ADA ID: 1BD0E685FC65 | Ramp Type: BlendTrans1 | Initial Pass/Fail: Fail | Overall Compliance: No |
| | | Severity Score: 10 | |

**Not Found, R304.5.1, R304.5.3**

| Compliance | Description | Data | Compliance | Description | Data |
|---|---|---|---|---|---|
| No | Ramp Width (in) | 46.0 | No | BlendTrans XSlope (%) | 2.7 |
| | | | No | Curb Slope (%) | 11.1 |

**Remove & Replace Curb Ramp With Two New Directional Ramps or Equivalent.**

Total Cost: \$ 3200.00
