Access Compliance Report

Public Rights-of-Way

(Curb Ramps)

Intersection ID: N/A	Main Street: ALLEGIANCE DR	Cross Street: LADY LIBERTY LN	Location: NW
ADA ID: 1BD92D49EB68	Ramp Type: BlendTrans1	Initial Pass/Fail: Fail	Overall Compliance: No
Severity Score: 36.25			
Codes/Mitigation Info/Possible Solution		Field Measurements/Component Compliance

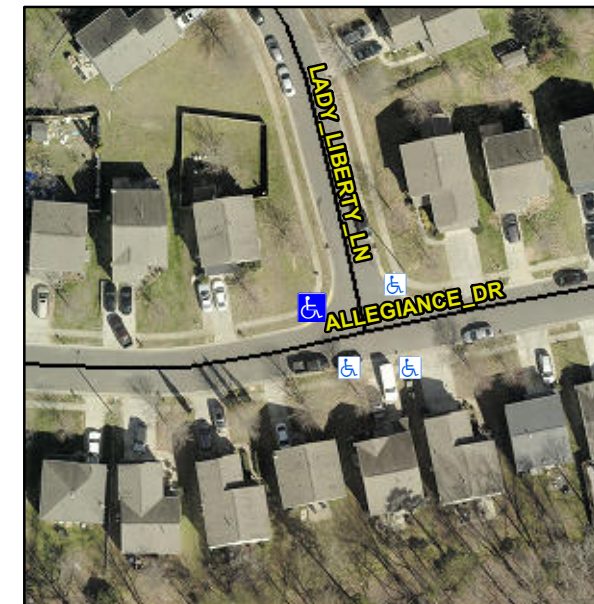
Not Found, R304.5.1, R304.5.3

Compliance	Description	Data	Compliance	Description	Data
N/A	Ramp Length (in)	49.0	Yes	BlendTrans Slope (%)	2.8
No	Ramp Width (in)	31.0	No	BlendTrans XSlope (%)	4.0
N/A	Flare Type LT	N/A	N/A	Flare Type RT	N/A
N/A	Flare Slope LT (%)	N/A	N/A	Flare Slope RT (%)	N/A
N/A	Flare Traversable LT?	No	N/A	Flare Traversable RT?	No
N/A	Landing Length (in)	N/A	N/A	DWS Provided?	N/A
N/A	Landing Width (in)	N/A	N/A	DWS Contrast?	N/A
N/A	Landing Slope (%)	N/A	N/A	DWS Length (in)	N/A
N/A	Landing X Slope (%)	N/A	N/A	DWS Full Width?	N/A
N/A	Landing Curb? (Y/N)	N/A	N/A	DWS Offset (in)	N/A
N/A	Shared Landing?	N/A			
N/A	Gutter Ponding?	N/A	N/A	Gutter Slope (%)	N/A
N/A	Gutter Lip Ht (in)	N/A	N/A	Gutter X Slope (%)	N/A
N/A	Painted X Walk1?	No	N/A	Painted X Walk2?	No
	X Walk 1 Direction	To S		X Walk 2 Direction	To E
	X Walk 1 Width (in)	N/A		X Walk 2 Width (in)	N/A
	X Walk 1 Slope (%)	0.1		X Walk 2 Slope (%)	4.9
	X Walk 1 X Slope (%)	4.9		X Walk 2 X Slope (%)	0.2

N/A	Ramp inside XWalk1?	N/A	N/A	Ramp inside XWalk2?	No
	Road Slope (%)	2.7		Clear Space?	N/A
	Road X Slope (%)	2.6	N/A	Clear Space to XWalk (in)	N/A
N/A	Any Obstructions?	N/A	N/A	Storm Grate/Utility Hazard?	N/A
	Obstruction Type			Storm Grate/Utility Type	
		N/A			N/A
			Yes	Surface Condition? (G/P)	Good
			No	Curb Slope (%)	10.3

Remove & Replace Curb Ramp With Two New Directional Ramps or Equivalent.
