# Access Compliance Report

## Public Rights-of-Way

### (Curb Ramps)

Intersection ID: 14213	Main Street: CENTRAL_AV	Cross Street: ROSEHAVEN_DR	Location: NE
ADA ID: 1BDBA62127C6	Ramp Type: Perp	Initial Pass/Fail: Fail	Overall Compliance: No
Severity Score: 8.75			
Codes/Mitigation Info/Possible Solution		Field Measurements/Component Compliance

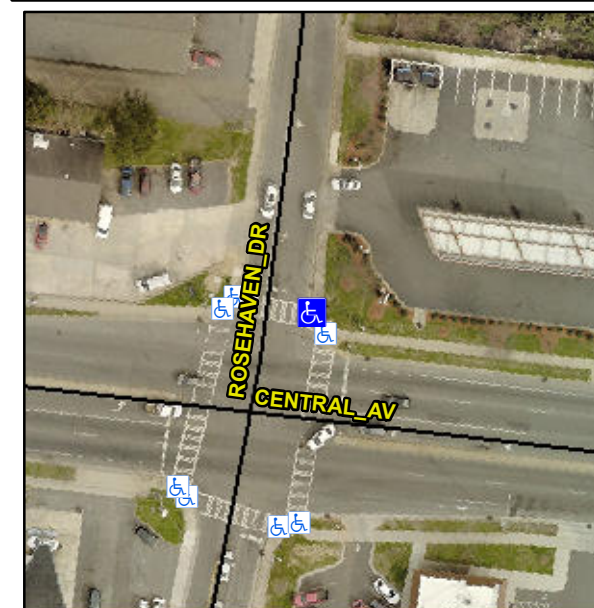
**Not Found, R304.5.1**

Compliance	Description	Data	Compliance	Description	Data
N/A	Ramp Length (in)	69.0	Yes	Ramp Slope (%)	5.5
No	Ramp Width (in)	41.0	Yes	Ramp XSlope (%)	1.5
N/A	Flare Type LT	N/A	N/A	Flare Type RT	N/A
N/A	Flare Slope LT (%)	N/A	N/A	Flare Slope RT (%)	N/A
N/A	Flare Traversable LT?	N/A	N/A	Flare Traversable RT?	N/A
N/A	Landing Length (in)	N/A	N/A	DWS Provided?	N/A
N/A	Landing Width (in)	N/A	N/A	DWS Contrast?	N/A
N/A	Landing Slope (%)	N/A	N/A	DWS Length (in)	N/A
N/A	Landing X Slope (%)	N/A	N/A	DWS Full Width?	N/A
N/A	Landing Curb? (Y/N)	N/A	N/A	DWS Offset (in)	N/A
N/A	Shared Landing?	N/A			
N/A	Gutter Ponding?	N/A	N/A	Gutter Slope (%)	N/A
N/A	Gutter Lip Ht (in)	N/A	N/A	Gutter X Slope (%)	N/A
N/A	Painted X Walk1?	Yes	N/A	Painted X Walk2?	N/A
	X Walk 1 Direction	To NW		X Walk 2 Direction	N/A
N/A	X Walk 1 Width (in)	114.0	N/A	X Walk 2 Width (in)	N/A
	X Walk 1 Slope (%)	2.5		X Walk 2 Slope (%)	N/A
	X Walk 1 X Slope (%)	0.8		X Walk 2 X Slope (%)	N/A

N/A	Ramp inside XWalk1?	Yes	N/A	Ramp inside XWalk2?	N/A
	Road Slope (%)	N/A	N/A	Clear Space?	N/A
	Road X Slope (%)	N/A	N/A	Clear Space to XWalk (in)	N/A
N/A	Any Obstructions?	N/A	N/A	Storm Grate/Utility Hazard?	N/A
	Obstruction Type			Storm Grate/Utility Type	
		N/A			N/A
			Yes	Surface Condition? (G/P)	Good

Possible Solutions:

**Remove & Replace Entire Ramp.**

Total Cost: \$ 1850.00
