Access Compliance Report

Public Rights-of-Way

(Curb Ramps)

Intersection ID: 10036062	Main Street: RIVERGATE_PY	Cross Street: N/A	Location: SW
ADA ID: 1BECEE6A2094	Ramp Type: BlendTrans2	Initial Pass/Fail: Fail	Overall Compliance: No
Severity Score: 1.25			
Codes/Mitigation Info/Possible Solution		Field Measurements/Component Compliance

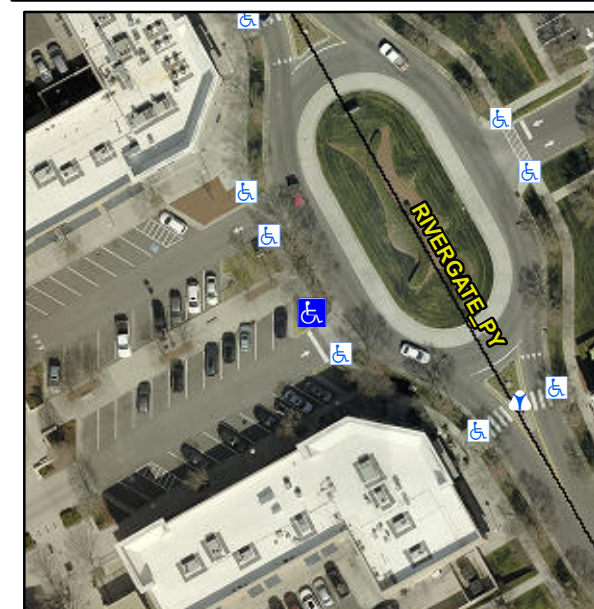
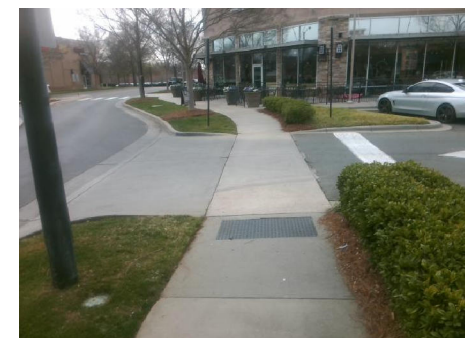
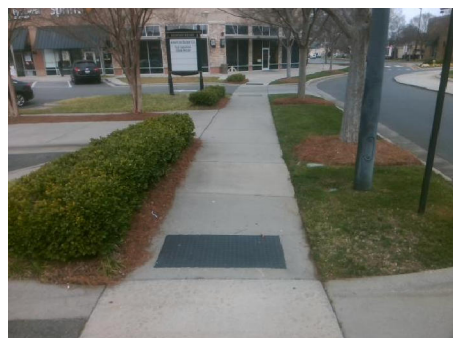
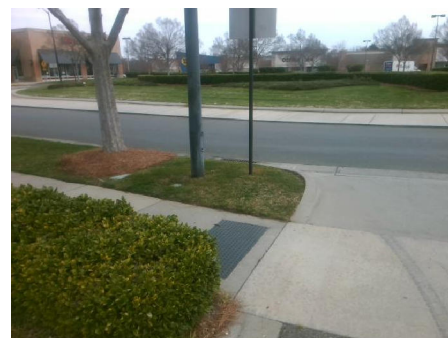
Compliance	Description	Data	Compliance	Description	Data
N/A	Ramp Length (in)	78.0	Yes	BlendTrans Slope (%)	0.4
Yes	Ramp Width (in)	72.0	No	BlendTrans XSlope (%)	4.0
N/A	Flare Type LT	N/A	N/A	Flare Type RT	N/A
N/A	Flare Slope LT (%)	N/A	N/A	Flare Slope RT (%)	N/A
N/A	Flare Traversable LT?	N/A	N/A	Flare Traversable RT?	N/A
N/A	Landing Length (in)	N/A	N/A	DWS Provided?	N/A
N/A	Landing Width (in)	N/A	N/A	DWS Contrast?	N/A
N/A	Landing Slope (%)	N/A	N/A	DWS Length (in)	N/A
N/A	Landing X Slope (%)	N/A	N/A	DWS Full Width?	N/A
N/A	Landing Curb? (Y/N)	N/A	N/A	DWS Offset (in)	N/A
N/A	Shared Landing?	N/A			
N/A	Gutter Ponding?	N/A	N/A	Gutter Slope (%)	N/A
N/A	Gutter Lip Ht (in)	N/A	N/A	Gutter X Slope (%)	N/A
N/A	Painted X Walk1?	No	N/A	Painted X Walk2?	N/A
	X Walk 1 Direction	To SE		X Walk 2 Direction	N/A
	X Walk 1 Width (in)	N/A		X Walk 2 Width (in)	N/A
	X Walk 1 Slope (%)	1.5		X Walk 2 Slope (%)	N/A
	X Walk 1 X Slope (%)	1.0		X Walk 2 X Slope (%)	N/A

N/A	Ramp inside XWalk1?	N/A	N/A	Ramp inside XWalk2?	N/A
	Road Slope (%)	1.9		Clear Space?	N/A
	Road X Slope (%)	1.5	N/A	Clear Space to XWalk (in)	N/A
N/A	Any Obstructions?	N/A	N/A	Storm Grate/Utility Hazard?	N/A
	Obstruction Type			Storm Grate/Utility Type	
		N/A			N/A
			Yes	Surface Condition? (G/P)	Good
			N/A	Curb Slope (%)	2.0

Possible Solutions:

Remove & Replace Curb Ramp With Two New Directional Ramps or Equivalent.

R304.5.3
