Access Compliance Report

Public Rights-of-Way

(Curb Ramps)

Intersection ID: 10943	Main Street: WALNUT_AV	Cross Street: WOODVALE_PL	Location: S
ADA ID: 1BF571F3B909	Ramp Type: PerpDiag	Initial Pass/Fail: Fail	Overall Compliance: No
Severity Score: 31.25			
Codes/Mitigation Info/Possible Solution		Field Measurements/Component Compliance

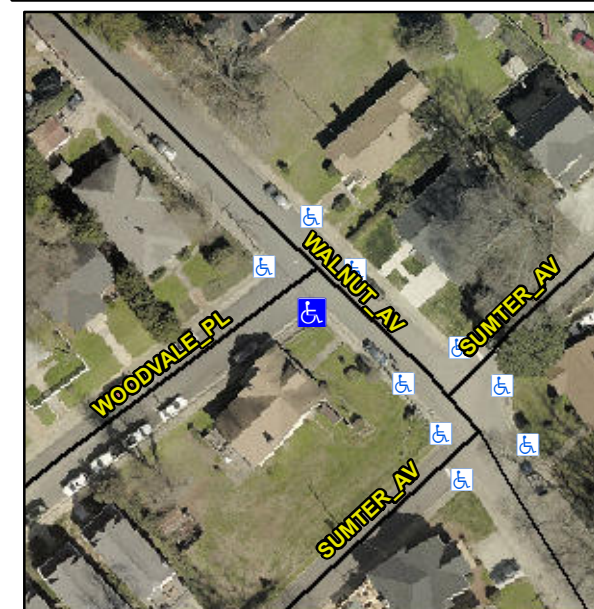
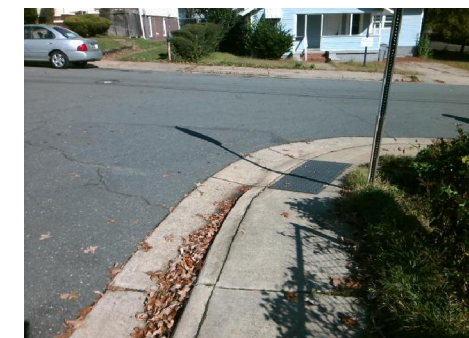
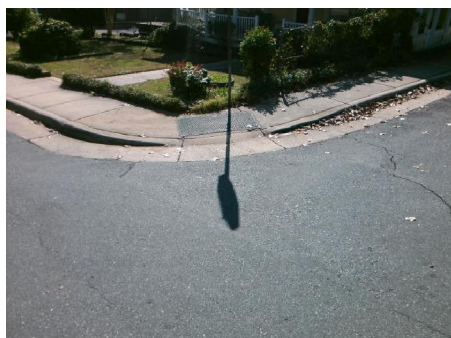
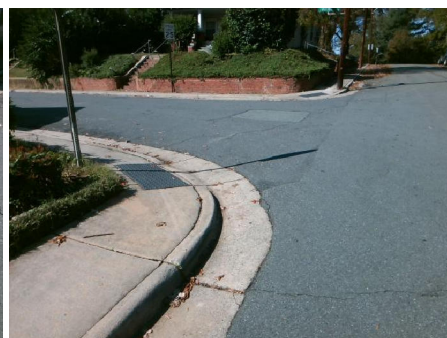
Not Found, R304.5.1, R304.2.2, R304.5.3

Compliance	Description	Data	Compliance	Description	Data
N/A	Ramp Length (in)	38.0	No	Ramp Slope (%)	8.4
No	Ramp Width (in)	33.0	No	Ramp XSlope (%)	3.8
N/A	Flare Type LT	N/A	N/A	Flare Type RT	N/A
N/A	Flare Slope LT (%)	N/A	N/A	Flare Slope RT (%)	N/A
N/A	Flare Traversable LT?	N/A	N/A	Flare Traversable RT?	N/A
N/A	Landing Length (in)	N/A	N/A	DWS Provided?	N/A
N/A	Landing Width (in)	N/A	N/A	DWS Contrast?	N/A
N/A	Landing Slope (%)	N/A	N/A	DWS Length (in)	N/A
N/A	Landing X Slope (%)	N/A	N/A	DWS Full Width?	N/A
N/A	Landing Curb? (Y/N)	N/A	N/A	DWS Offset (in)	N/A
N/A	Shared Landing?	N/A			
N/A	Gutter Ponding?	N/A	N/A	Gutter Slope (%)	N/A
N/A	Gutter Lip Ht (in)	N/A	N/A	Gutter X Slope (%)	N/A
N/A	Painted X Walk1?	No	N/A	Painted X Walk2?	No
	X Walk 1 Direction	To NE		X Walk 2 Direction	To NW
N/A	X Walk 1 Width (in)	N/A	N/A	X Walk 2 Width (in)	N/A
	X Walk 1 Slope (%)	5.0		X Walk 2 Slope (%)	8.6
	X Walk 1 X Slope (%)	9.2		X Walk 2 X Slope (%)	1.5

N/A	Ramp inside XWalk1?	N/A	N/A	Ramp inside XWalk2?	N/A
	Road Slope (%)	2.3	N/A	Clear Space?	N/A
	Road X Slope (%)	14.0	N/A	Clear Space to XWalk (in)	N/A
N/A	Any Obstructions?	N/A	N/A	Storm Grate/Utility Hazard?	N/A
	Obstruction Type			Storm Grate/Utility Type	
		N/A			N/A
			Yes	Surface Condition? (G/P)	Good

Remove & Replace Curb Ramp With Two New Directional Ramps or Equivalent.
