## **Access Compliance Report Public Rights-of-Way** (Curb Ramps)

Intersection ID: 26783 Main Street: CREEK BEND DR Cross Street: ELM LN Location: SW Initial Pass/Fail: Fail **Overall Compliance: No Severity Score:** 12.5 ADA ID: 1BFB61158527 Ramp Type: PerpDiag

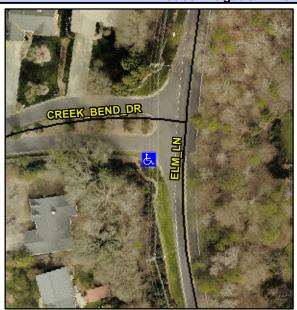
**ELM LN** Street 1 Name Stop Condition-Street 2 None **CREEK BEND DR** Street 2 Name Stop Condition-Street 1 StopSign Possible Solutions: Compliance Description N/A Remove & Replace Curb Ramp With Two New Directional Ramps or Yes Equivalent. Surveyor Notes: N/A PROW/ADA: Not Found, R304.5.3
