Access Compliance Report

Public Rights-of-Way

(Curb Ramps)

Intersection ID: 5585	Main Street: MCCULLOUGH_DR	Cross Street: UNIVERSITY_CENTER_BV	Location: NW
ADA ID: 1BFDD2946130	Ramp Type: Perp	Initial Pass/Fail: Fail	Overall Compliance: No
		Severity Score: 22.5

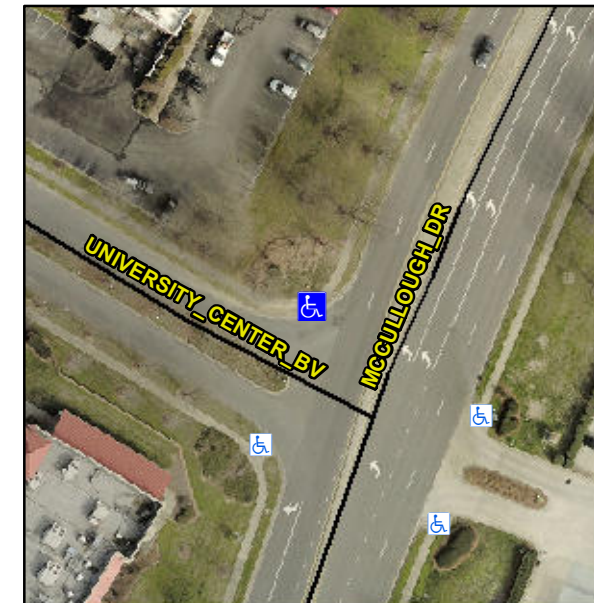
Not Found, R304.5.1, R304.2.2, R304.5.3

Compliance	Description	Data	Compliance	Description	Data
N/A	Ramp Length (in)	47.0	No	Ramp Slope (%)	8.7
No	Ramp Width (in)	47.0	No	Ramp XSlope (%)	4.1
N/A	Flare Type LT	N/A	N/A	Flare Type RT	N/A
N/A	Flare Slope LT (%)	N/A	N/A	Flare Slope RT (%)	N/A
N/A	Flare Traversable LT?	N/A	N/A	Flare Traversable RT?	N/A
N/A	Landing Length (in)	N/A	N/A	DWS Provided?	N/A
N/A	Landing Width (in)	N/A	N/A	DWS Contrast?	N/A
N/A	Landing Slope (%)	N/A	N/A	DWS Length (in)	N/A
N/A	Landing X Slope (%)	N/A	N/A	DWS Full Width?	N/A
N/A	Landing Curb? (Y/N)	N/A	N/A	DWS Offset (in)	N/A
N/A	Shared Landing?	N/A			
N/A	Gutter Ponding?	N/A	N/A	Gutter Slope (%)	N/A
N/A	Gutter Lip Ht (in)	1.0	N/A	Gutter X Slope (%)	N/A
N/A	Painted X Walk1?	No	N/A	Painted X Walk2?	N/A
	X Walk 1 Direction	To SW		X Walk 2 Direction	N/A
N/A	X Walk 1 Width (in)	N/A	N/A	X Walk 2 Width (in)	N/A
	X Walk 1 Slope (%)	4.3		X Walk 2 Slope (%)	N/A
	X Walk 1 X Slope (%)	0.8		X Walk 2 X Slope (%)	N/A

N/A	Ramp inside XWalk1?	N/A	N/A	Ramp inside XWalk2?	N/A
	Road Slope (%)	N/A	N/A	Clear Space?	N/A
	Road X Slope (%)	N/A	N/A	Clear Space to XWalk (in)	N/A
N/A	Any Obstructions?	N/A	N/A	Storm Grate/Utility Hazard?	N/A
	Obstruction Type			Storm Grate/Utility Type	
		N/A			N/A
			Yes	Surface Condition? (G/P)	Good

Remove & Replace Entire Ramp.
