Access Compliance Report

Public Rights-of-Way

(Curb Ramps)

Intersection ID: 18844	Main Street: NATIONS_FORD_RD	Cross Street: TYVOLA_RD	Location: NW
ADA ID: 1C0348A3D215	Ramp Type: PerpDiag	Initial Pass/Fail: Fail	Overall Compliance: No
Severity Score: 22.5			
Codes/Mitigation Info/Possible Solution		Field Measurements/Component Compliance

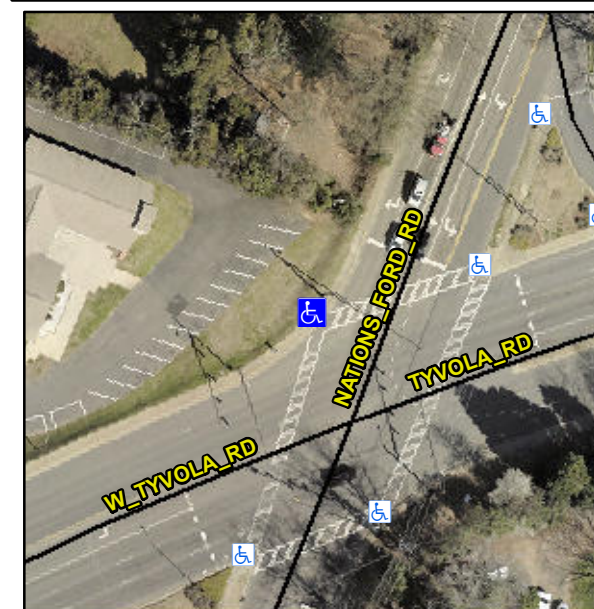
Not Found, R304.5.1, R304.2.2, R304.5.3

Compliance	Description	Data	Compliance	Description	Data
N/A	Ramp Length (in)	58.0	No	Ramp Slope (%)	9.6
No	Ramp Width (in)	40.0	No	Ramp XSlope (%)	2.1
N/A	Flare Type LT	N/A	N/A	Flare Type RT	N/A
N/A	Flare Slope LT (%)	N/A	N/A	Flare Slope RT (%)	N/A
N/A	Flare Traversable LT?	N/A	N/A	Flare Traversable RT?	N/A
N/A	Landing Length (in)	N/A	N/A	DWS Provided?	N/A
N/A	Landing Width (in)	N/A	N/A	DWS Contrast?	N/A
N/A	Landing Slope (%)	N/A	N/A	DWS Length (in)	N/A
N/A	Landing X Slope (%)	N/A	N/A	DWS Full Width?	N/A
N/A	Landing Curb? (Y/N)	N/A	N/A	DWS Offset (in)	N/A
N/A	Shared Landing?	N/A			
N/A	Gutter Ponding?	N/A	N/A	Gutter Slope (%)	N/A
N/A	Gutter Lip Ht (in)	N/A	N/A	Gutter X Slope (%)	N/A
N/A	Painted X Walk1?	Yes	N/A	Painted X Walk2?	Yes
	X Walk 1 Direction	To SW		X Walk 2 Direction	To E
N/A	X Walk 1 Width (in)	67.0	N/A	X Walk 2 Width (in)	105.0
	X Walk 1 Slope (%)	0.5		X Walk 2 Slope (%)	0.6
	X Walk 1 X Slope (%)	2.0		X Walk 2 X Slope (%)	0.5

Remove & Replace Curb Ramp With Two New Directional Ramps or Equivalent.

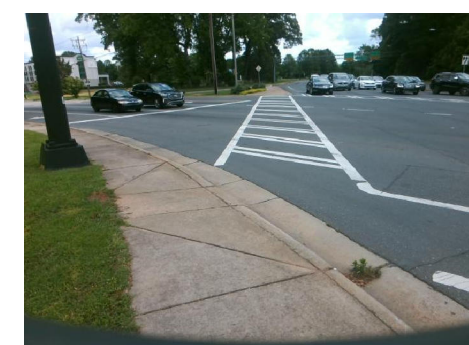
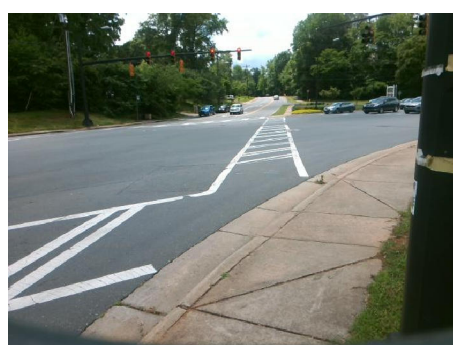
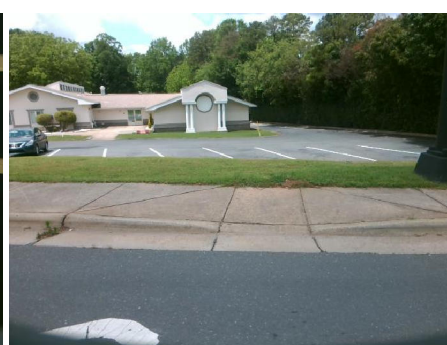
N/A	Ramp inside XWalk1?	Yes	N/A	Ramp inside XWalk2?	Yes
	Road Slope (%)	0.2	N/A	Clear Space?	N/A
	Road X Slope (%)	0.6	N/A	Clear Space to XWalk (in)	N/A
N/A	Any Obstructions?	N/A	N/A	Storm Grate/Utility Hazard?	N/A
	Obstruction Type			Storm Grate/Utility Type	
		N/A			N/A
		Yes		Surface Condition? (G/P)	Good
