Access Compliance Report

Public Rights-of-Way

(Curb Ramps)

Intersection ID: 47616	Main Street: TWISTED_PINE_DR	Cross Street: CANIPE_DR	Location: E
ADA ID: 1C085677EAE7	Ramp Type: Perp	Initial Pass/Fail: Fail	Overall Compliance: No
			Severity Score: 21.25

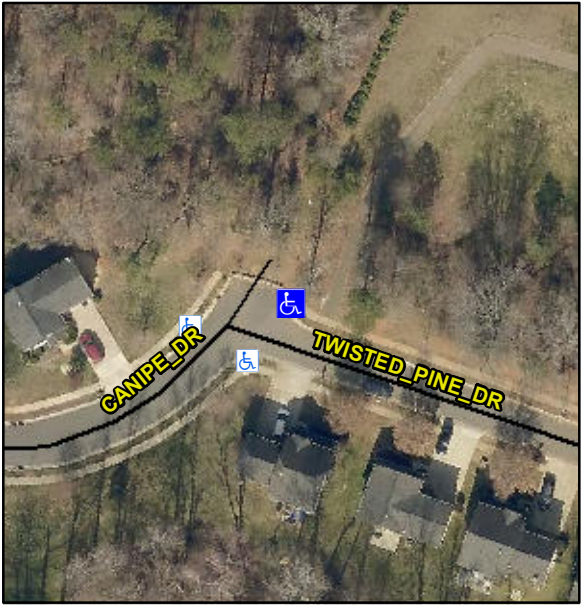
Possible Solutions:						
	Remove & Replace Entire Ramp.	N/A	Ramp Length (in)	48.5	Yes	Ramp Slope (%)	5.3
		No	Ramp Width (in)	47.5	No	Ramp XSlope (%)	6.8
		N/A	Flare Type LT	N/A	N/A	Flare Type RT	N/A
		N/A	Flare Slope LT (%)	N/A	N/A	Flare Slope RT (%)	N/A
		N/A	Flare Traversable LT?	N/A	N/A	Flare Traversable RT?	N/A
		N/A	Landing Length (in)	N/A	N/A	DWS Provided?	N/A
		N/A	Landing Width (in)	N/A	N/A	DWS Contrast?	N/A
		N/A	Landing Slope (%)	N/A	N/A	DWS Length (in)	N/A
		N/A	Landing X Slope (%)	N/A	N/A	DWS Full Width?	N/A
		N/A	Landing Curb? (Y/N)	N/A	N/A	DWS Offset (in)	N/A
		N/A	Shared Landing?	N/A			
		N/A	Gutter Ponding?	N/A	N/A	Gutter Slope (%)	N/A
		N/A	Gutter Lip Ht (in)	N/A	N/A	Gutter X Slope (%)	N/A
		N/A	Painted X Walk1?	No	N/A	Painted X Walk2?	N/A
			X Walk 1 Direction	To SW		X Walk 2 Direction	N/A
		N/A	X Walk 1 Width (in)	N/A	N/A	X Walk 2 Width (in)	N/A

X Walk 1 Slope (%)	5.0		X Walk 2 Slope (%)	N/A
			X Walk 1 X Slope (%)	4.8		X Walk 2 X Slope (%)	N/A
		N/A	Ramp inside XWalk1?	N/A	N/A	Ramp inside XWalk2?	N/A
<p>Surveyor Notes:</p> <p>N/A</p> <p>PROW/ADA:</p> <p>Not Found, R304.5.1, R304.5.3</p>							
			Road Slope (%)	N/A	N/A	Clear Space?	N/A
			Road X Slope (%)	N/A	N/A	Clear Space to XWalk (in)	N/A
		N/A	Any Obstructions?	N/A	N/A	Storm Grate/Utility Hazard?	N/A
			Obstruction Type			Storm Grate/Utility Type	
					N/A		N/A
					Yes	Surface Condition? (G/P)	Good

Total Cost: \$ 1850.00
