Access Compliance Report

Public Rights-of-Way

(Curb Ramps)

Intersection ID: N/A	Main Street: E_4TH_ST	Cross Street: S_CALDWELL_ST	Location: S
ADA ID: 1C0A400AA3BB	Ramp Type: Perp	Initial Pass/Fail: Fail	Overall Compliance: No
		Severity Score: 12.5	
Codes/Mitigation Info/Possible Solution		Field Measurements/Component Compliance

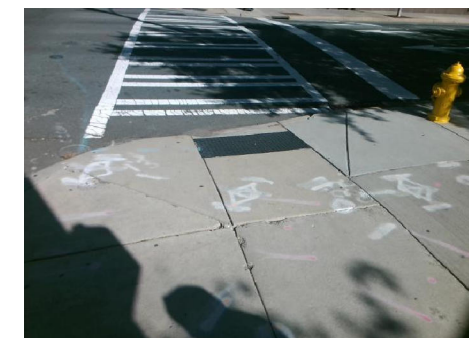
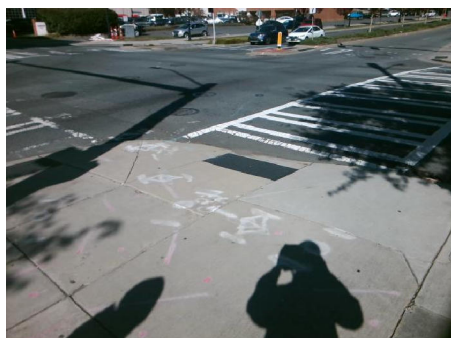
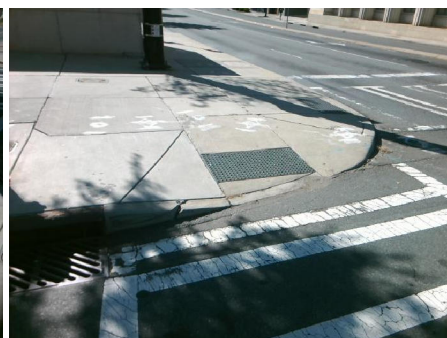
Compliance	Description	Data	Compliance	Description	Data
N/A	Ramp Length (in)	75.0	No	Ramp Slope (%)	8.9
Yes	Ramp Width (in)	48.0	Yes	Ramp XSlope (%)	0.0
N/A	Flare Type LT	N/A	N/A	Flare Type RT	N/A
N/A	Flare Slope LT (%)	N/A	N/A	Flare Slope RT (%)	N/A
N/A	Flare Traversable LT?	No	N/A	Flare Traversable RT?	No
N/A	Landing Length (in)	N/A	N/A	DWS Provided?	N/A
N/A	Landing Width (in)	N/A	N/A	DWS Contrast?	N/A
N/A	Landing Slope (%)	N/A	N/A	DWS Length (in)	N/A
N/A	Landing X Slope (%)	N/A	N/A	DWS Full Width?	N/A
N/A	Landing Curb? (Y/N)	N/A	N/A	DWS Offset (in)	N/A
N/A	Shared Landing?	N/A			
N/A	Gutter Ponding?	N/A	N/A	Gutter Slope (%)	N/A
N/A	Gutter Lip Ht (in)	N/A	N/A	Gutter X Slope (%)	N/A
N/A	Painted X Walk1?	Yes	N/A	Painted X Walk2?	N/A
	X Walk 1 Direction	To NE		X Walk 2 Direction	N/A
N/A	X Walk 1 Width (in)	120.0	N/A	X Walk 2 Width (in)	N/A
	X Walk 1 Slope (%)	4.8		X Walk 2 Slope (%)	N/A
	X Walk 1 X Slope (%)	0.7		X Walk 2 X Slope (%)	N/A

N/A	Ramp inside XWalk1?	Yes	N/A	Ramp inside XWalk2?	N/A
	Road Slope (%)	N/A	N/A	Clear Space?	N/A
	Road X Slope (%)	N/A	N/A	Clear Space to XWalk (in)	N/A
N/A	Any Obstructions?	N/A	N/A	Storm Grate/Utility Hazard?	N/A
	Obstruction Type			Storm Grate/Utility Type	
		N/A			N/A
			Yes	Surface Condition? (G/P)	Good

Possible Solutions:

Remove & Replace Entire Ramp.

Total Cost: \$ 1850.00
