Access Compliance Report

Public Rights-of-Way

(Curb Ramps)

Intersection ID: 44207	Main Street: MOCKERNUT_DR	Cross Street: TARTARIAN_CT	Location: SE
ADA ID: 1C0EC500D523	Ramp Type: PerpDiag	Initial Pass/Fail: Fail	Overall Compliance: No
Severity Score: 22.5			
Codes/Mitigation Info/Possible Solution		Field Measurements/Component Compliance

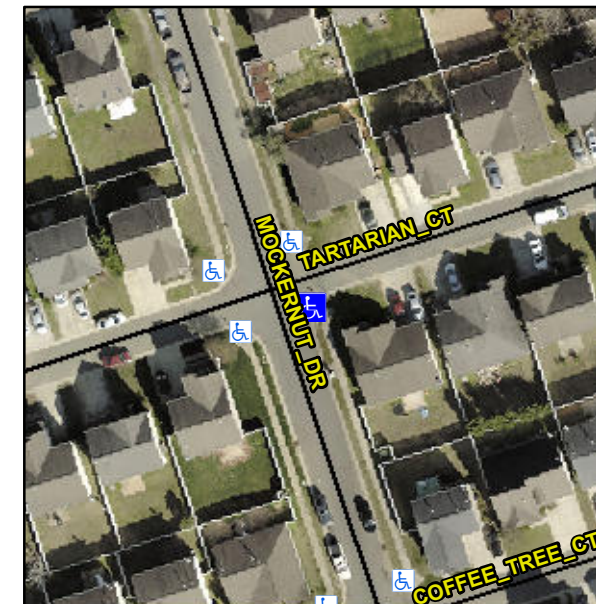
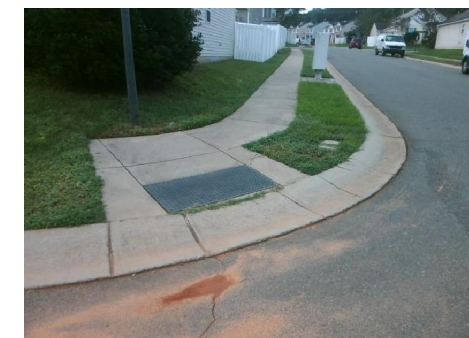
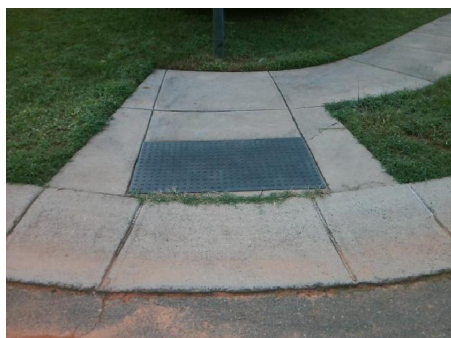
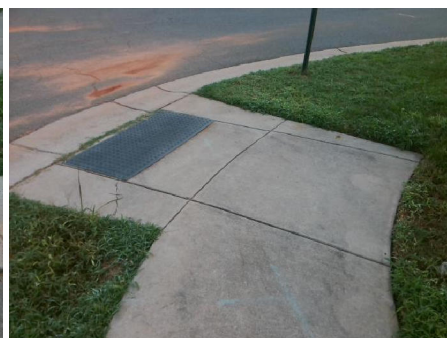
Not Found, R304.5.1, R304.2.2, R304.5.3

Compliance	Description	Data	Compliance	Description	Data
N/A	Ramp Length (in)	48.5	No	Ramp Slope (%)	10.6
No	Ramp Width (in)	47.5	No	Ramp XSlope (%)	3.2
N/A	Flare Type LT	N/A	N/A	Flare Type RT	N/A
N/A	Flare Slope LT (%)	N/A	N/A	Flare Slope RT (%)	N/A
N/A	Flare Traversable LT?	N/A	N/A	Flare Traversable RT?	N/A
N/A	Landing Length (in)	N/A	N/A	DWS Provided?	N/A
N/A	Landing Width (in)	N/A	N/A	DWS Contrast?	N/A
N/A	Landing Slope (%)	N/A	N/A	DWS Length (in)	N/A
N/A	Landing X Slope (%)	N/A	N/A	DWS Full Width?	N/A
N/A	Landing Curb? (Y/N)	N/A	N/A	DWS Offset (in)	N/A
N/A	Shared Landing?	N/A			
N/A	Gutter Ponding?	N/A	N/A	Gutter Slope (%)	N/A
N/A	Gutter Lip Ht (in)	1.0	N/A	Gutter X Slope (%)	N/A
N/A	Painted X Walk1?	No	N/A	Painted X Walk2?	No
	X Walk 1 Direction	To N		X Walk 2 Direction	To W
N/A	X Walk 1 Width (in)	N/A	N/A	X Walk 2 Width (in)	N/A
	X Walk 1 Slope (%)	0.0		X Walk 2 Slope (%)	4.0
	X Walk 1 X Slope (%)	0.6		X Walk 2 X Slope (%)	2.2

N/A	Ramp inside XWalk1?	N/A	N/A	Ramp inside XWalk2?	N/A
	Road Slope (%)	1.0	N/A	Clear Space?	N/A
	Road X Slope (%)	1.4	N/A	Clear Space to XWalk (in)	N/A
N/A	Any Obstructions?	N/A	N/A	Storm Grate/Utility Hazard?	N/A
	Obstruction Type			Storm Grate/Utility Type	
		N/A			N/A
			Yes	Surface Condition? (G/P)	Good

Possible Solutions:

Remove & Replace Curb Ramp With Two New Directional Ramps or Equivalent.
