# Access Compliance Report

## Public Rights-of-Way (Curb Ramps)

| Intersection ID: 7076 | Main Street: ACORN_OAKS_RD | Cross Street: BEGONIA_DR | Location: W |
| ADA ID: 1C13F7348902 | Ramp Type: Perp | Initial Pass/Fail: Pass | Overall Compliance: No |

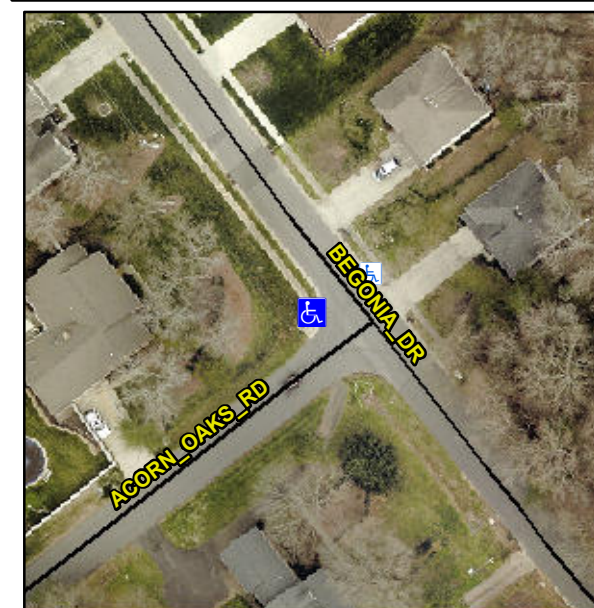
**Not Found, R304.5.3, R304.2.1,  
R304.2.2-Perp, R304.3.2-Para,  
R304.2.3, R305.2, R302.7.2, R304.5.4**

| Compliance | Description | Data | Compliance | Description | Data |
|---|---|---|---|---|---|
| N/A | Ramp Length (in) | 45.5 | Yes | Ramp Slope (%) | 5.6 |
| Yes | Ramp Width (in) | 48.0 | No | Ramp XSlope (%) | 4.4 |
| No | Landing Length (in) | 46.0 | Yes | DWS Provided? | Yes |
| No | Landing Slope (%) | 4.4 | Yes | DWS Length (in) | 24.0 |
| No | Landing X Slope (%) | 5.0 | Yes | DWS Full Width? | Yes |
| N/A | Landing Curb? (Y/N) | No | No | DWS Offset (in) | 5.0 |
| Yes | Gutter Ponding? | No | No | Gutter Slope (%) | 12.2 |
| No | Gutter Lip Ht (in) | 1.0 | Yes | Gutter X Slope (%) | 2.3 |

**Remove & Replace Entire Ramp.  
Remove & Replace Gutter.**
