# Access Compliance Report

## Public Rights-of-Way

### (Curb Ramps)

Intersection ID: 19496	Main Street: CRANFORD_DR	Cross Street: PARK_RD	Location: NW
ADA ID: 1C17D8D1780E	Ramp Type: Perp	Initial Pass/Fail: Fail	Overall Compliance: No
Severity Score: 12.5			
Codes/Mitigation Info/Possible Solution		Field Measurements/Component Compliance

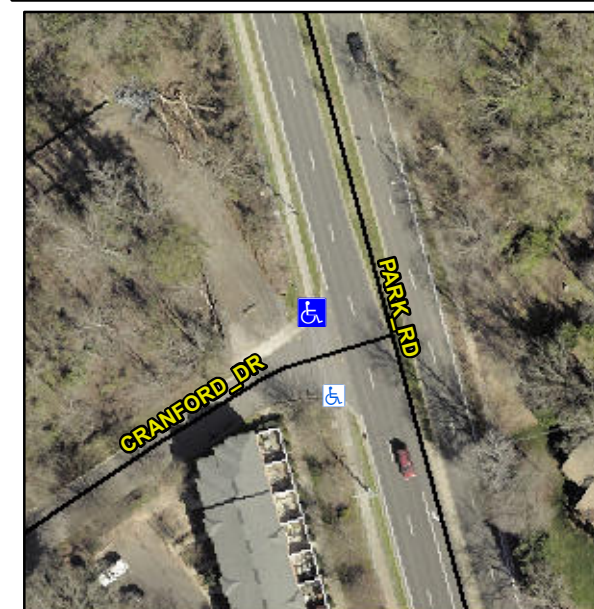
**Not Found, R304.2.2**

Compliance	Description	Data	Compliance	Description	Data
N/A	Ramp Length (in)	55.0	No	Ramp Slope (%)	9.1
Yes	Ramp Width (in)	48.0	Yes	Ramp XSlope (%)	0.9
N/A	Flare Type LT	N/A	N/A	Flare Type RT	N/A
N/A	Flare Slope LT (%)	N/A	N/A	Flare Slope RT (%)	N/A
N/A	Flare Traversable LT?	N/A	N/A	Flare Traversable RT?	N/A
N/A	Landing Length (in)	N/A	N/A	DWS Provided?	N/A
N/A	Landing Width (in)	N/A	N/A	DWS Contrast?	N/A
N/A	Landing Slope (%)	N/A	N/A	DWS Length (in)	N/A
N/A	Landing X Slope (%)	N/A	N/A	DWS Full Width?	N/A
N/A	Landing Curb? (Y/N)	N/A	N/A	DWS Offset (in)	N/A
N/A	Shared Landing?	N/A			
N/A	Gutter Ponding?	N/A	N/A	Gutter Slope (%)	N/A
N/A	Gutter Lip Ht (in)	N/A	N/A	Gutter X Slope (%)	N/A
N/A	Painted X Walk1?	No	N/A	Painted X Walk2?	N/A
	X Walk 1 Direction	To S		X Walk 2 Direction	N/A
N/A	X Walk 1 Width (in)	N/A	N/A	X Walk 2 Width (in)	N/A
	X Walk 1 Slope (%)	2.0		X Walk 2 Slope (%)	N/A
	X Walk 1 X Slope (%)	1.6		X Walk 2 X Slope (%)	N/A

Possible Solutions:

**Remove & Replace Entire Ramp.**

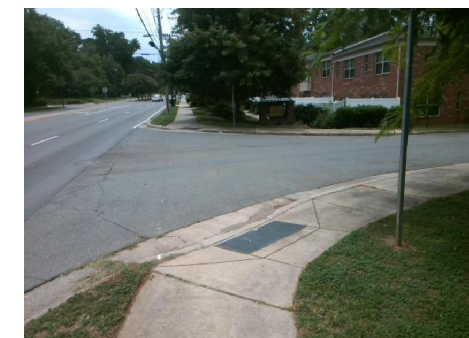
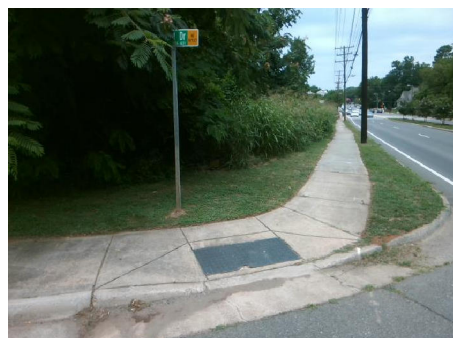
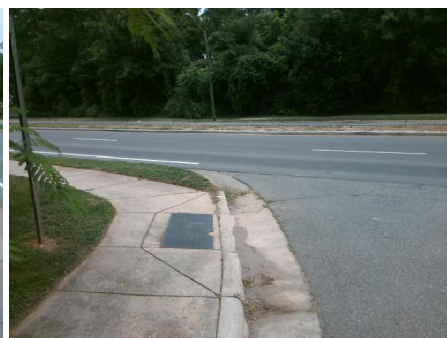
N/A	Ramp inside XWalk1?	N/A	N/A	Ramp inside XWalk2?	N/A
	Road Slope (%)	N/A	N/A	Clear Space?	N/A
	Road X Slope (%)	N/A	N/A	Clear Space to XWalk (in)	N/A
N/A	Any Obstructions?	N/A	N/A	Storm Grate/Utility Hazard?	N/A
	Obstruction Type			Storm Grate/Utility Type	
		N/A			N/A
			Yes	Surface Condition? (G/P)	Good
