## Access Compliance Report Public Rights-of-Way (Curb Ramps)

Intersection ID: 28944 Main Street: ROLAND\_ST Cross Street: LOGIE\_AV Location: SW

ADA ID: 1C1A6987F431 Ramp Type: Para Initial Pass/Fail: Fail Overall Compliance: No Severity Score: 26.25

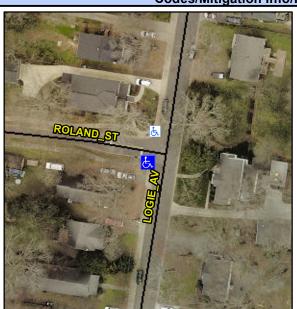
CCCIDIC CCIALICII	
Possible Solutions:	Co
Remove & Replace Entire Ramp.	N/A
·	Ye
	Ye
	Ye
	N/A
	N/A
Surveyor Notes:	N/A
LT RP < 5%	N/A
	N/A
	N/A
	N/A
PROW/ADA:	N/A
R304.3.2, R304.5.3	N/A
	N/J
	N/

Compl		Data		nent Compliance liance Description	Data
N/A	Ramp Length LT (in)	37.0	N/A	Ramp Length RT (in)	44.0
Yes	Ramp Width LT (in)	73.0	Yes	Ramp Width RT (in)	72.0
Yes	Ramp Slope LT (%)	1.8	No	Ramp Slope RT (%)	12.8
Yes	Ramp XSlope LT (%)	1.7	No	Ramp XSlope RT (%)	3.8
N/A	Landing Length (in)	N/A	N/A	DWS Provided?	N/A
N/A	Landing Width (in)	N/A	N/A	DWS Contrast?	N/A
N/A	Landing Slope (%)	N/A	N/A	DWS Length (in)	N/A
N/A	Landing X Slope (%)	N/A	N/A	DWS Full Width?	N/A
N/A	Landing Curb? (Y/N)	N/A	N/A	DWS Offset (in)	N/A
N/A	Shared Landing?	N/A			
N/A	Gutter Ponding?	N/A	N/A	Gutter Slope (%)	N/A
N/A	Gutter Lip Ht (in)	N/A	N/A	Gutter X Slope (%)	N/A
N/A	Painted X Walk1?	No	N/A	Painted X Walk2?	N/A
	X Walk 1 Direction	To N		X Walk 2 Direction	N/A
N/A	X Walk 1 Width (in)	N/A	N/A	X Walk 2 Width (in)	N/A
	X Walk 1 Slope (%)	3.1		X Walk 2 Slope (%)	N/A
	X Walk 1 X Slope (%)	3.1		X Walk 2 X Slope (%)	N/A
N/A	Ramp inside XWalk1?	N/A	N/A	Ramp inside XWalk2?	N/A

Road Slope (%)	N/A	N/A	Clear Space?	N/A
	Road X Slope (%)	N/A	N/A	Clear Space to XWalk (in)	N/A
N/A	Any Obstructions?	N/A	N/A	Storm Grate/Utility Hazard?	N/A
	Obstruction Type			Storm Grate/Utility Type	
		N/A			N/A
			Yes	Surface Condition? (G/P)	Good
			N/A	Curb Slope (%)	10.2
				,	P)
