# Access Compliance Report

### (Curb Ramps)

| Intersection ID: 2500 | Main Street: CAMBRIDGE_BAY_DR | Cross Street: VISCOUNT_LN | Location: | S |
| ADA ID: 1C1C4EED7AEF | Ramp Type: PerpDiag | Initial Pass/Fail: Fail | Overall Compliance: No | Severity Score: 10 |

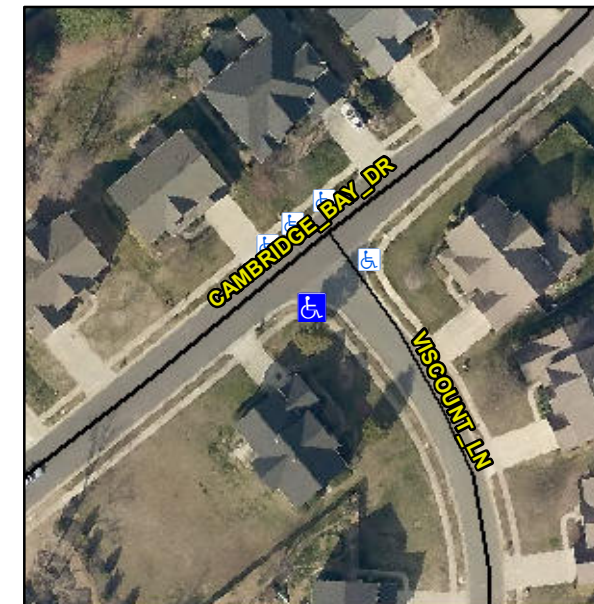
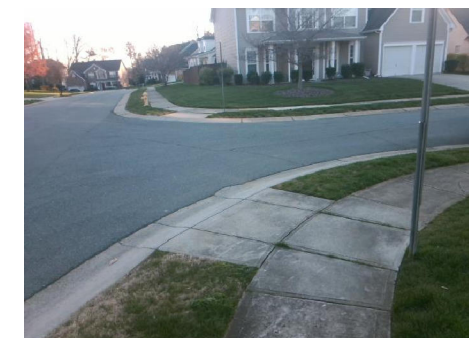
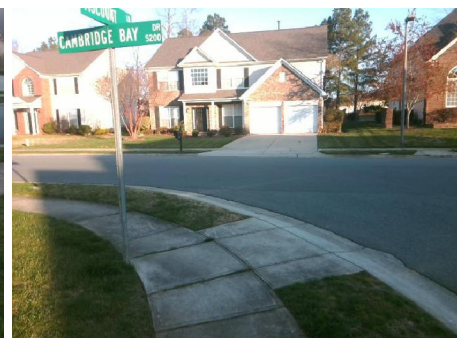
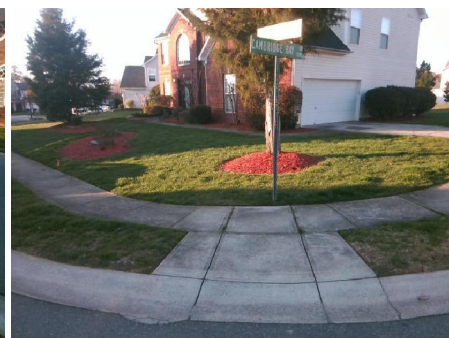
**Not Found, R304.5.1, R304.5.3**

| Compliance | Description | Data | Compliance | Description | Data |
|---|---|---|---|---|---|
| No | Ramp Width (in) | 42.5 | No | Ramp XSlope (%) | 3.4 |

**Remove & Replace Curb Ramp With Two New Directional Ramps or Equivalent.**
