Access Compliance Report

Public Rights-of-Way

(Curb Ramps)

Intersection ID: 44489	Main Street: CHALKSTONE_RD	Cross Street: BREWSTER_ST	Location: NW
ADA ID: 1C269C0A0180	Ramp Type: BlendTrans1	Initial Pass/Fail: Fail	Overall Compliance: No
Severity Score: 10			
Codes/Mitigation Info/Possible Solution		Field Measurements/Component Compliance

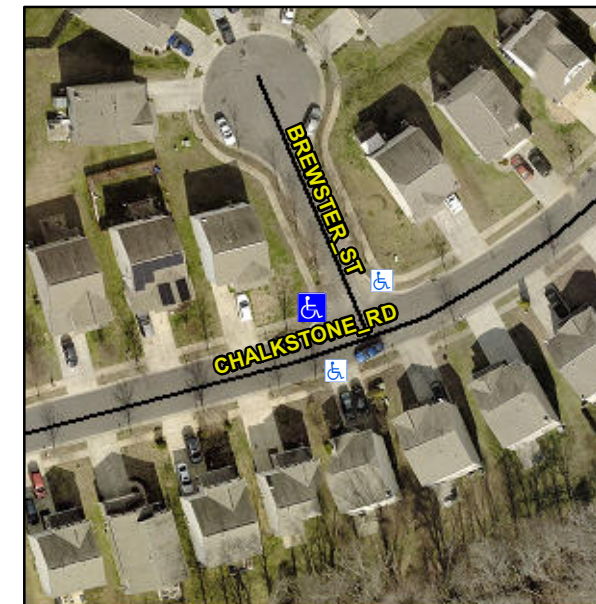
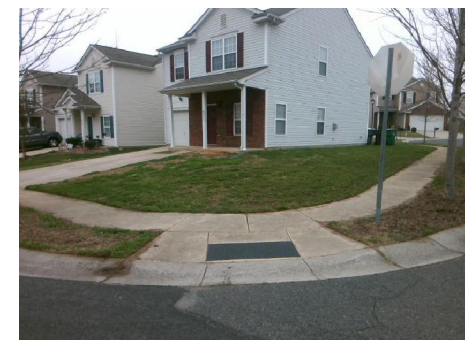
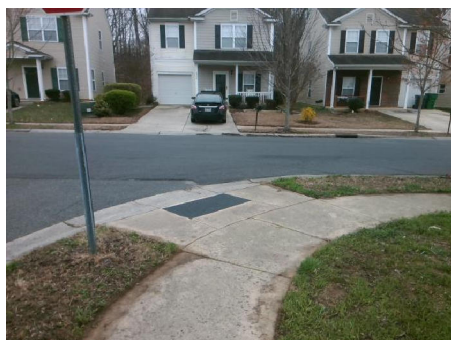
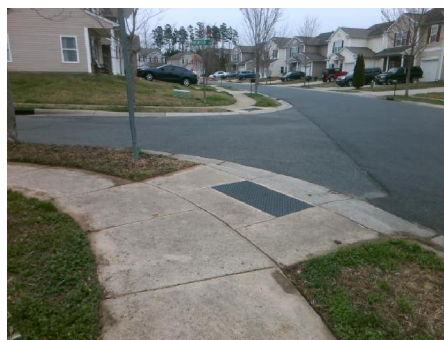
Not Found, R304.5.1, R304.5.3

Compliance	Description	Data	Compliance	Description	Data
N/A	Ramp Length (in)	47.0	Yes	BlendTrans Slope (%)	3.7
No	Ramp Width (in)	46.0	No	BlendTrans XSlope (%)	2.6
N/A	Flare Type LT	N/A	N/A	Flare Type RT	N/A
N/A	Flare Slope LT (%)	N/A	N/A	Flare Slope RT (%)	N/A
N/A	Flare Traversable LT?	N/A	N/A	Flare Traversable RT?	N/A
N/A	Landing Length (in)	N/A	N/A	DWS Provided?	N/A
N/A	Landing Width (in)	N/A	N/A	DWS Contrast?	N/A
N/A	Landing Slope (%)	N/A	N/A	DWS Length (in)	N/A
N/A	Landing X Slope (%)	N/A	N/A	DWS Full Width?	N/A
N/A	Landing Curb? (Y/N)	N/A	N/A	DWS Offset (in)	N/A
N/A	Shared Landing?	N/A			
N/A	Gutter Ponding?	N/A	N/A	Gutter Slope (%)	N/A
N/A	Gutter Lip Ht (in)	N/A	N/A	Gutter X Slope (%)	N/A
N/A	Painted X Walk1?	No	N/A	Painted X Walk2?	No
	X Walk 1 Direction	To S		X Walk 2 Direction	To E
	X Walk 1 Width (in)	N/A		X Walk 2 Width (in)	N/A
	X Walk 1 Slope (%)	3.5		X Walk 2 Slope (%)	2.6
	X Walk 1 X Slope (%)	2.9		X Walk 2 X Slope (%)	0.4

N/A	Ramp inside XWalk1?	N/A	N/A	Ramp inside XWalk2?	N/A
	Road Slope (%)	3.1		Clear Space?	N/A
	Road X Slope (%)	0.1	N/A	Clear Space to XWalk (in)	N/A
N/A	Any Obstructions?	N/A	N/A	Storm Grate/Utility Hazard?	N/A
	Obstruction Type			Storm Grate/Utility Type	
		N/A			N/A
			Yes	Surface Condition? (G/P)	Good
			No	Curb Slope (%)	12.2

Remove & Replace Curb Ramp With Two New Directional Ramps or Equivalent.
