Access Compliance Report

Public Rights-of-Way

(Curb Ramps)

| Intersection ID: 9444 | Main Street: JUDSON_AV | Cross Street: ZEBULON_AV | Location: W |

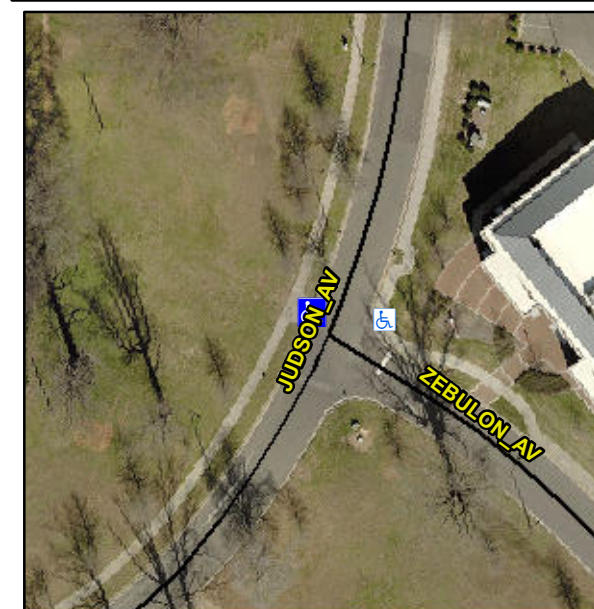
| ADA ID: 1C2E5F2CD11F | Ramp Type: Perp | Initial Pass/Fail: Fail | Overall Compliance: No |

Not Found, R304.2.2

| Compliance | Description | Data | Compliance | Description | Data |
|---|---|---|---|---|---|
| N/A | Ramp Length (in) | 97.0 | No | Ramp Slope (%) | 9.0 |

Remove & Replace Entire Ramp.
