# Access Compliance Report

## Public Rights-of-Way

### (Curb Ramps)

Intersection ID: 48786	Main Street: LOST_OAK_RD	Cross Street: ALEXANDER_RD	Location: NW
ADA ID: 1C3E247E050B	Ramp Type: PerpDiag	Initial Pass/Fail: Fail	Overall Compliance: No
Severity Score: 10			
Codes/Mitigation Info/Possible Solution		Field Measurements/Component Compliance

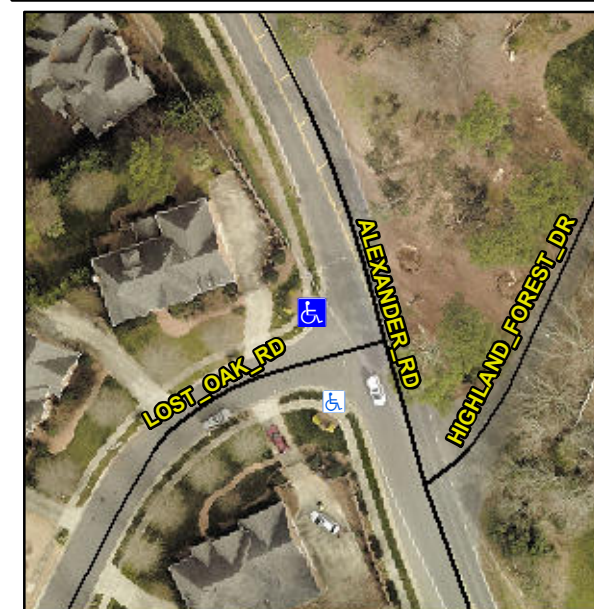
Compliance	Description	Data	Compliance	Description	Data
N/A	Ramp Length (in)	100.0	Yes	Ramp Slope (%)	6.8
No	Ramp Width (in)	44.5	No	Ramp XSlope (%)	4.4
N/A	Flare Type LT	N/A	N/A	Flare Type RT	N/A
N/A	Flare Slope LT (%)	N/A	N/A	Flare Slope RT (%)	N/A
N/A	Flare Traversable LT?	N/A	N/A	Flare Traversable RT?	N/A
N/A	Landing Length (in)	N/A	N/A	DWS Provided?	N/A
N/A	Landing Width (in)	N/A	N/A	DWS Contrast?	N/A
N/A	Landing Slope (%)	N/A	N/A	DWS Length (in)	N/A
N/A	Landing X Slope (%)	N/A	N/A	DWS Full Width?	N/A
N/A	Landing Curb? (Y/N)	N/A	N/A	DWS Offset (in)	N/A
N/A	Shared Landing?	N/A			
N/A	Gutter Ponding?	N/A	N/A	Gutter Slope (%)	N/A
N/A	Gutter Lip Ht (in)	N/A	N/A	Gutter X Slope (%)	N/A
N/A	Painted X Walk1?	No	N/A	Painted X Walk2?	No
	X Walk 1 Direction	To S		X Walk 2 Direction	To E
N/A	X Walk 1 Width (in)	N/A	N/A	X Walk 2 Width (in)	N/A
	X Walk 1 Slope (%)	3.1		X Walk 2 Slope (%)	1.5
	X Walk 1 X Slope (%)	3.9		X Walk 2 X Slope (%)	3.4

N/A	Ramp inside XWalk1?	N/A	N/A	Ramp inside XWalk2?	N/A
	Road Slope (%)	4.0	N/A	Clear Space?	N/A
	Road X Slope (%)	0.3	N/A	Clear Space to XWalk (in)	N/A
N/A	Any Obstructions?	N/A	N/A	Storm Grate/Utility Hazard?	N/A
	Obstruction Type			Storm Grate/Utility Type	
		N/A			N/A
		Yes		Surface Condition? (G/P)	Good

**Remove & Replace Curb Ramp With Two New Directional Ramps or Equivalent.**

**R304.5.1, R304.5.3**
