Access Compliance Report

Public Rights-of-Way

(Curb Ramps)

Intersection ID: 30018	Main Street: W_MALLARD_CREEK_CHURCH_DR	Cross Street: BERKELEY_PLACE_DR	Location: NE
ADA ID: 1C441F0AB7D5	Ramp Type: Perp	Initial Pass/Fail: Fail	Overall Compliance: No
Severity Score: 22.5			
Codes/Mitigation Info/Possible Solution		Field Measurements/Component Compliance

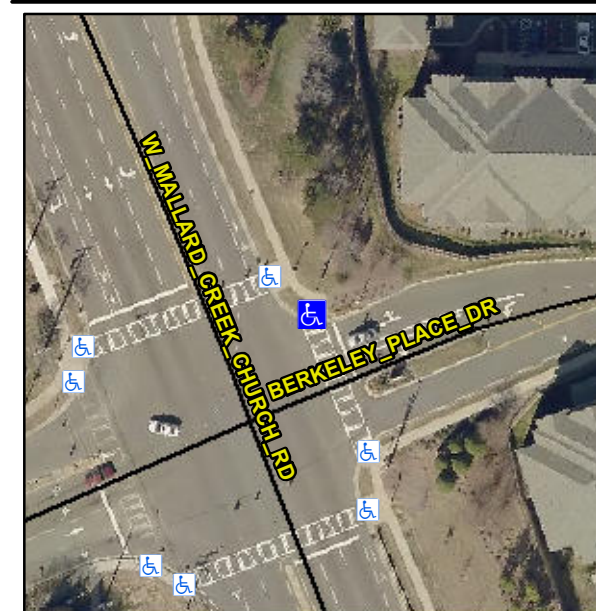
Compliance	Description	Data	Compliance	Description	Data
N/A	Ramp Length (in)	85.0	No	Ramp Slope (%)	8.6
No	Ramp Width (in)	47.0	No	Ramp XSlope (%)	5.0
N/A	Flare Type LT	N/A	N/A	Flare Type RT	N/A
N/A	Flare Slope LT (%)	N/A	N/A	Flare Slope RT (%)	N/A
N/A	Flare Traversable LT?	N/A	N/A	Flare Traversable RT?	N/A
N/A	Landing Length (in)	N/A	N/A	DWS Provided?	N/A
N/A	Landing Width (in)	N/A	N/A	DWS Contrast?	N/A
N/A	Landing Slope (%)	N/A	N/A	DWS Length (in)	N/A
N/A	Landing X Slope (%)	N/A	N/A	DWS Full Width?	N/A
N/A	Landing Curb? (Y/N)	N/A	N/A	DWS Offset (in)	N/A
N/A	Shared Landing?	N/A			
N/A	Gutter Ponding?	N/A	N/A	Gutter Slope (%)	N/A
N/A	Gutter Lip Ht (in)	N/A	N/A	Gutter X Slope (%)	N/A
N/A	Painted X Walk1?	Yes	N/A	Painted X Walk2?	N/A
	X Walk 1 Direction	To S		X Walk 2 Direction	N/A
N/A	X Walk 1 Width (in)	115.0	N/A	X Walk 2 Width (in)	N/A
	X Walk 1 Slope (%)	1.7		X Walk 2 Slope (%)	N/A
	X Walk 1 X Slope (%)	4.3		X Walk 2 X Slope (%)	N/A

N/A	Ramp inside XWalk1?	Yes	N/A	Ramp inside XWalk2?	N/A
	Road Slope (%)	N/A	N/A	Clear Space?	N/A
	Road X Slope (%)	N/A	N/A	Clear Space to XWalk (in)	N/A
N/A	Any Obstructions?	N/A	N/A	Storm Grate/Utility Hazard?	N/A
	Obstruction Type			Storm Grate/Utility Type	
		N/A			N/A
			Yes	Surface Condition? (G/P)	Good

Possible Solutions:

Remove & Replace Entire Ramp.
