Access Compliance Report

Public Rights-of-Way

(Curb Ramps)

Intersection ID: 4979	Main Street: BETTERTON_LN	Cross Street: CRISFIELD_RD	Location: SW
ADA ID: 1C5C2BEE7EB8	Ramp Type: Perp	Initial Pass/Fail: Fail	Overall Compliance: No
Severity Score: 1.25			
Codes/Mitigation Info/Possible Solution		Field Measurements/Component Compliance

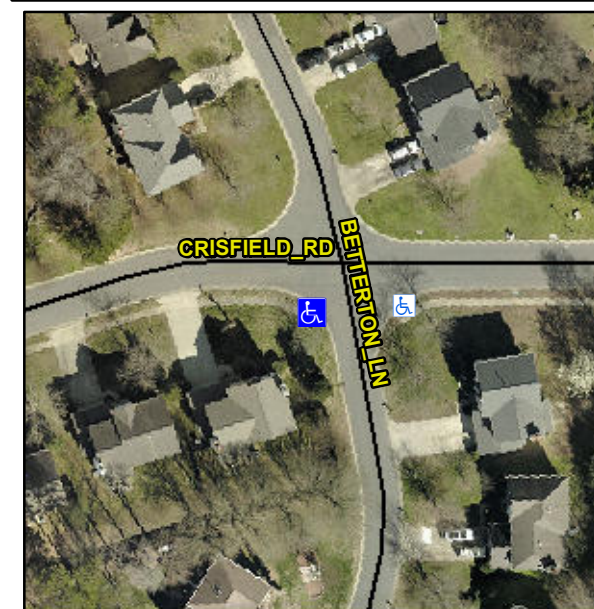
Compliance	Description	Data	Compliance	Description	Data
N/A	Ramp Length (in)	46.5	Yes	Ramp Slope (%)	7.3
Yes	Ramp Width (in)	48.0	No	Ramp XSlope (%)	3.1
N/A	Flare Type LT	N/A	N/A	Flare Type RT	N/A
N/A	Flare Slope LT (%)	N/A	N/A	Flare Slope RT (%)	N/A
N/A	Flare Traversable LT?	N/A	N/A	Flare Traversable RT?	N/A
N/A	Landing Length (in)	N/A	N/A	DWS Provided?	N/A
N/A	Landing Width (in)	N/A	N/A	DWS Contrast?	N/A
N/A	Landing Slope (%)	N/A	N/A	DWS Length (in)	N/A
N/A	Landing X Slope (%)	N/A	N/A	DWS Full Width?	N/A
N/A	Landing Curb? (Y/N)	N/A	N/A	DWS Offset (in)	N/A
N/A	Shared Landing?	N/A			
N/A	Gutter Ponding?	N/A	N/A	Gutter Slope (%)	N/A
N/A	Gutter Lip Ht (in)	N/A	N/A	Gutter X Slope (%)	N/A
N/A	Painted X Walk1?	No	N/A	Painted X Walk2?	N/A
	X Walk 1 Direction	To E		X Walk 2 Direction	N/A
N/A	X Walk 1 Width (in)	N/A	N/A	X Walk 2 Width (in)	N/A
	X Walk 1 Slope (%)	3.2		X Walk 2 Slope (%)	N/A
	X Walk 1 X Slope (%)	2.8		X Walk 2 X Slope (%)	N/A

N/A	Ramp inside XWalk1?	N/A	N/A	Ramp inside XWalk2?	N/A
	Road Slope (%)	N/A	N/A	Clear Space?	N/A
	Road X Slope (%)	N/A	N/A	Clear Space to XWalk (in)	N/A
N/A	Any Obstructions?	N/A	N/A	Storm Grate/Utility Hazard?	N/A
	Obstruction Type			Storm Grate/Utility Type	
		N/A			N/A
			Yes	Surface Condition? (G/P)	Good

Possible Solutions:

Remove & Replace Entire Ramp.

R304.5.3
