Access Compliance Report

Public Rights-of-Way

(Curb Ramps)

Intersection ID: 10021845	Main Street: BRIXHAM_HILL_AV	Cross Street: N/A	Location: NE
ADA ID: 1C6034FA0E84	Ramp Type: Perp	Initial Pass/Fail: Fail	Overall Compliance: No
Codes/Mitigation Info/Possible Solution		Field Measurements/Component Compliance	
Severity Score: 10

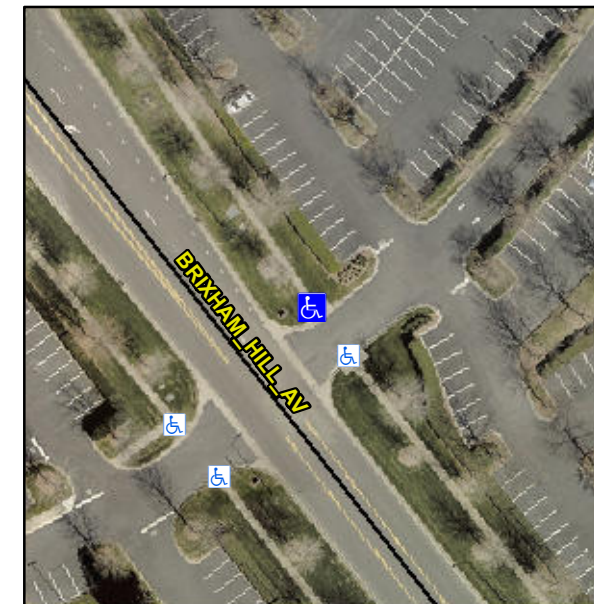
Not Found, R304.5.1, R304.5.3

Compliance	Description	Data	Compliance	Description	Data
N/A	Ramp Length (in)	59.0	Yes	Ramp Slope (%)	5.1
No	Ramp Width (in)	47.0	No	Ramp XSlope (%)	4.8
N/A	Flare Type LT	N/A	N/A	Flare Type RT	N/A
N/A	Flare Slope LT (%)	N/A	N/A	Flare Slope RT (%)	N/A
N/A	Flare Traversable LT?	N/A	N/A	Flare Traversable RT?	N/A
N/A	Landing Length (in)	N/A	N/A	DWS Provided?	N/A
N/A	Landing Width (in)	N/A	N/A	DWS Contrast?	N/A
N/A	Landing Slope (%)	N/A	N/A	DWS Length (in)	N/A
N/A	Landing X Slope (%)	N/A	N/A	DWS Full Width?	N/A
N/A	Landing Curb? (Y/N)	N/A	N/A	DWS Offset (in)	N/A
N/A	Shared Landing?	N/A			
N/A	Gutter Ponding?	N/A	N/A	Gutter Slope (%)	N/A
N/A	Gutter Lip Ht (in)	N/A	N/A	Gutter X Slope (%)	N/A
N/A	Painted X Walk1?	No	N/A	Painted X Walk2?	N/A
	X Walk 1 Direction	To SE		X Walk 2 Direction	N/A
N/A	X Walk 1 Width (in)	N/A	N/A	X Walk 2 Width (in)	N/A
	X Walk 1 Slope (%)	2.8		X Walk 2 Slope (%)	N/A
	X Walk 1 X Slope (%)	4.2		X Walk 2 X Slope (%)	N/A

N/A	Ramp inside XWalk1?	N/A	N/A	Ramp inside XWalk2?	N/A
	Road Slope (%)	N/A	N/A	Clear Space?	N/A
	Road X Slope (%)	N/A	N/A	Clear Space to XWalk (in)	N/A
N/A	Any Obstructions?	N/A	N/A	Storm Grate/Utility Hazard?	N/A
	Obstruction Type			Storm Grate/Utility Type	
		N/A			N/A
			Yes	Surface Condition? (G/P)	Good

Possible Solutions:

Remove & Replace Entire Ramp.
