Access Compliance Report

Public Rights-of-Way

(Curb Ramps)

Intersection ID: 25464	Main Street: ASHLIGHT_DR	Cross Street: HATTON_CROSS_DR	Location: SW
ADA ID: 1C61B22EBCA6	Ramp Type: PerpDiag	Initial Pass/Fail: Fail	Overall Compliance: No
		Severity Score: 35

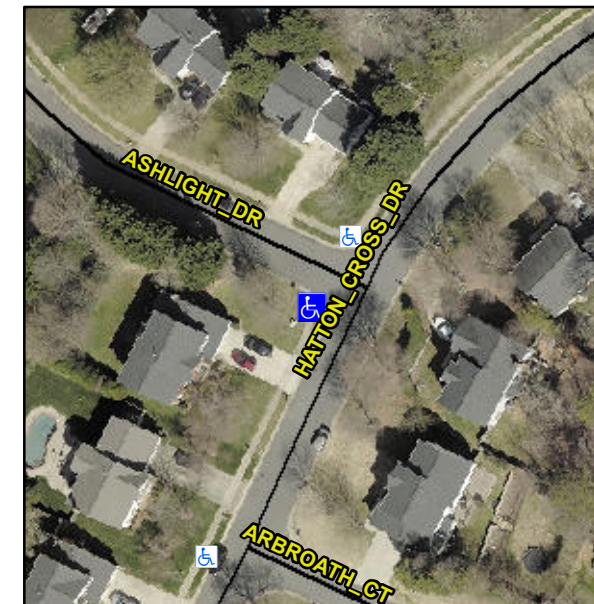
Not Found, R304.5.1

Compliance	Description	Data	Compliance	Description	Data
N/A	Ramp Length (in)	97.0	Yes	Ramp Slope (%)	6.2
No	Ramp Width (in)	31.0	Yes	Ramp XSlope (%)	2.0
N/A	Flare Type LT	N/A	N/A	Flare Type RT	N/A
N/A	Flare Slope LT (%)	N/A	N/A	Flare Slope RT (%)	N/A
N/A	Flare Traversable LT?	N/A	N/A	Flare Traversable RT?	N/A
N/A	Landing Length (in)	N/A	N/A	DWS Provided?	N/A
N/A	Landing Width (in)	N/A	N/A	DWS Contrast?	N/A
N/A	Landing Slope (%)	N/A	N/A	DWS Length (in)	N/A
N/A	Landing X Slope (%)	N/A	N/A	DWS Full Width?	N/A
N/A	Landing Curb? (Y/N)	N/A	N/A	DWS Offset (in)	N/A
N/A	Shared Landing?	N/A			
N/A	Gutter Ponding?	N/A	N/A	Gutter Slope (%)	N/A
N/A	Gutter Lip Ht (in)	N/A	N/A	Gutter X Slope (%)	N/A
N/A	Painted X Walk1?	No	N/A	Painted X Walk2?	No
	X Walk 1 Direction	To SE		X Walk 2 Direction	To NE
N/A	X Walk 1 Width (in)	N/A	N/A	X Walk 2 Width (in)	N/A
	X Walk 1 Slope (%)	1.4		X Walk 2 Slope (%)	10.6
	X Walk 1 X Slope (%)	6.7		X Walk 2 X Slope (%)	1.9

N/A	Ramp inside XWalk1?	N/A	N/A	Ramp inside XWalk2?	N/A
	Road Slope (%)	2.7	N/A	Clear Space?	N/A
	Road X Slope (%)	11.0	N/A	Clear Space to XWalk (in)	N/A
N/A	Any Obstructions?	N/A	N/A	Storm Grate/Utility Hazard?	N/A
	Obstruction Type			Storm Grate/Utility Type	
		N/A			N/A
			Yes	Surface Condition? (G/P)	Good

Possible Solutions:

Remove & Replace Curb Ramp With Two New Directional Ramps or Equivalent.
