# Access Compliance Report

## Public Rights-of-Way

### (Curb Ramps)

Intersection ID: 16629	Main Street: HAVERHILL_DR	Cross Street: SCALEYBARK_RD	Location:	S
ADA ID: 1C6307FA107D	Ramp Type: Combination1Diag	Initial Pass/Fail: Fail	Overall Compliance: No	Severity Score: 0

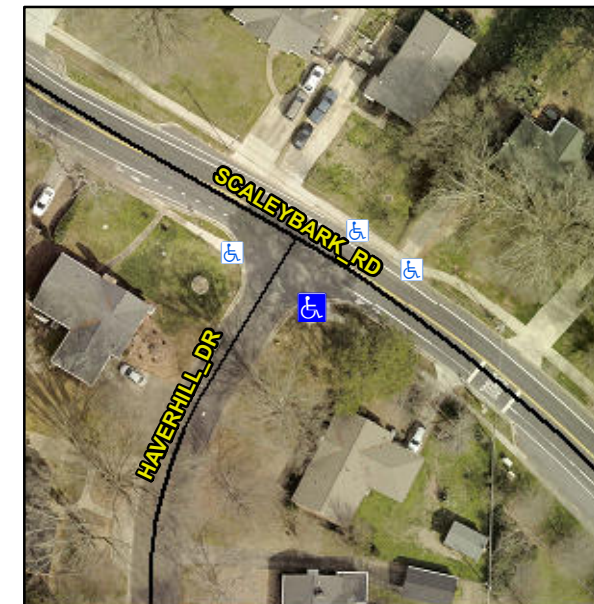
Compliance	Description	Data	Compliance	Description	Data
N/A	Ramp Length LT (in)	51.0	N/A	Ramp Length RT (in)	40.0
Yes	Ramp Width LT (in)	60.0	Yes	Ramp Width RT (in)	59.5
Yes	Ramp Slope LT (%)	6.6	No	Ramp Slope RT (%)	8.9
Yes	Ramp XSlope LT (%)	0.4	Yes	Ramp XSlope RT (%)	0.4
N/A	Ramp Length (in)	61.0	Yes	Ramp Slope (%)	2.2
Yes	Ramp Width (in)	54.0	Yes	Ramp XSlope (%)	1.4
N/A	Flare Type LT	N/A	N/A	Flare Type RT	N/A
N/A	Flare Slope LT (%)	N/A	N/A	Flare Slope RT (%)	N/A
N/A	Flare Traversable LT?	N/A	N/A	Flare Traversable RT?	N/A
N/A	Landing Length (in)	N/A	N/A	DWS Provided?	N/A
N/A	Landing Width (in)	N/A	N/A	DWS Contrast?	N/A
N/A	Landing Slope (%)	N/A	N/A	DWS Length (in)	N/A
N/A	Landing X Slope (%)	N/A	N/A	DWS Full Width?	N/A
N/A	Landing Curb? (Y/N)	N/A	N/A	DWS Offset (in)	N/A
N/A	Shared Landing?	N/A			
N/A	Gutter Ponding?	N/A	N/A	Gutter Slope (%)	N/A
N/A	Gutter Lip Ht (in)	N/A	N/A	Gutter X Slope (%)	N/A
N/A	Painted X Walk1?	No	N/A	Painted X Walk2?	No

X Walk 1 Direction	To NE		X Walk 2 Direction	To NW
	X Walk 1 Width (in)	N/A		X Walk 2 Width (in)	N/A
	X Walk 1 Slope (%)	2.1		X Walk 2 Slope (%)	2.9
	X Walk 1 X Slope (%)	1.5		X Walk 2 X Slope (%)	0.5
N/A	Ramp inside XWalk1?	N/A	N/A	Ramp inside XWalk2?	N/A
	Road Slope (%)	2.7		Clear Space?	N/A
	Road X Slope (%)	3.5	N/A	Clear Space to XWalk (in)	N/A
			N/A	Any Obstruction?	N/A
				Obstruction Type	N/A
			N/A	Storm Grate/Utility Hazard?	N/A
				Storm Grate/Utility Type	N/A
			Yes	Surface Condition? (G/P)	Good
				Curb Slope (%)	0.7

**Remove & Replace Curb Ramp With Two New Directional Ramps or Equivalent.**

**R304.3.2**
