Access Compliance Report

Public Rights-of-Way

(Curb Ramps)

Intersection ID: 54151	Main Street: SANDERS_FARM_LN	Cross Street: WALNUT_FOREST_DR	Location: NW
ADA ID: 1C632C6DBD34	Ramp Type: Perp	Initial Pass/Fail: Fail	Overall Compliance: No
Severity Score: 8.75			
Codes/Mitigation Info/Possible Solution		Field Measurements/Component Compliance

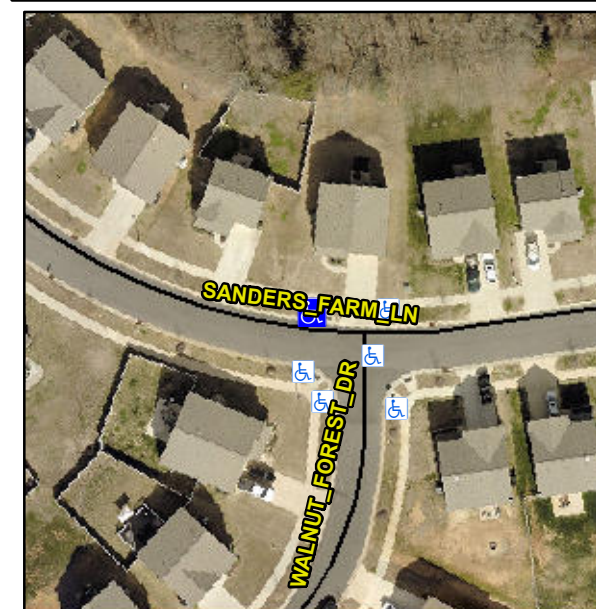
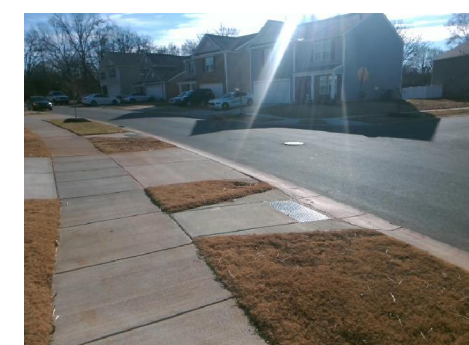
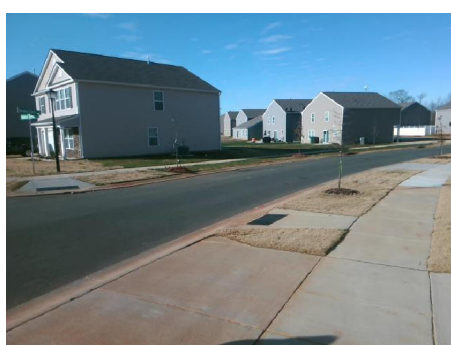
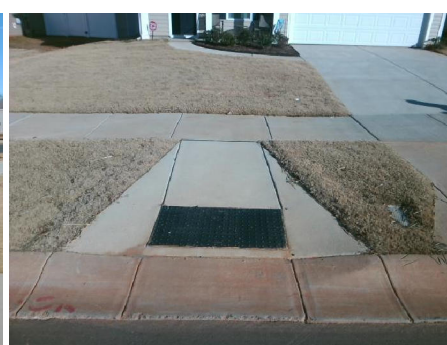
Compliance	Description	Data	Compliance	Description	Data
N/A	Ramp Length (in)	96.0	Yes	Ramp Slope (%)	8.2
No	Ramp Width (in)	44.5	Yes	Ramp XSlope (%)	0.9
N/A	Flare Type LT	N/A	N/A	Flare Type RT	N/A
N/A	Flare Slope LT (%)	N/A	N/A	Flare Slope RT (%)	N/A
N/A	Flare Traversable LT?	N/A	N/A	Flare Traversable RT?	N/A
N/A	Landing Length (in)	N/A	N/A	DWS Provided?	N/A
N/A	Landing Width (in)	N/A	N/A	DWS Contrast?	N/A
N/A	Landing Slope (%)	N/A	N/A	DWS Length (in)	N/A
N/A	Landing X Slope (%)	N/A	N/A	DWS Full Width?	N/A
N/A	Landing Curb? (Y/N)	N/A	N/A	DWS Offset (in)	N/A
N/A	Shared Landing?	N/A			
N/A	Gutter Ponding?	N/A	N/A	Gutter Slope (%)	N/A
N/A	Gutter Lip Ht (in)	N/A	N/A	Gutter X Slope (%)	N/A
N/A	Painted X Walk1?	No	N/A	Painted X Walk2?	N/A
	X Walk 1 Direction	To S		X Walk 2 Direction	N/A
N/A	X Walk 1 Width (in)	N/A	N/A	X Walk 2 Width (in)	N/A
	X Walk 1 Slope (%)	4.3		X Walk 2 Slope (%)	N/A
	X Walk 1 X Slope (%)	2.2		X Walk 2 X Slope (%)	N/A

N/A	Ramp inside XWalk1?	N/A	N/A	Ramp inside XWalk2?	N/A
	Road Slope (%)	N/A	N/A	Clear Space?	N/A
	Road X Slope (%)	N/A	N/A	Clear Space to XWalk (in)	N/A
N/A	Any Obstructions?	N/A	N/A	Storm Grate/Utility Hazard?	N/A
	Obstruction Type			Storm Grate/Utility Type	
		N/A			N/A
			Yes	Surface Condition? (G/P)	Good

Possible Solutions:

Remove & Replace Entire Ramp.
