# Access Compliance Report

## Public Rights-of-Way

### (Curb Ramps)

Intersection ID: 31486	Main Street: CLOVER_GAP_DR	Cross Street: ELISE_MARIE_DR	Location:	N
ADA ID: 1C677FF2F26E	Ramp Type: PerpDiag	Initial Pass/Fail: Fail	Overall Compliance: No	Severity Score: 17.5

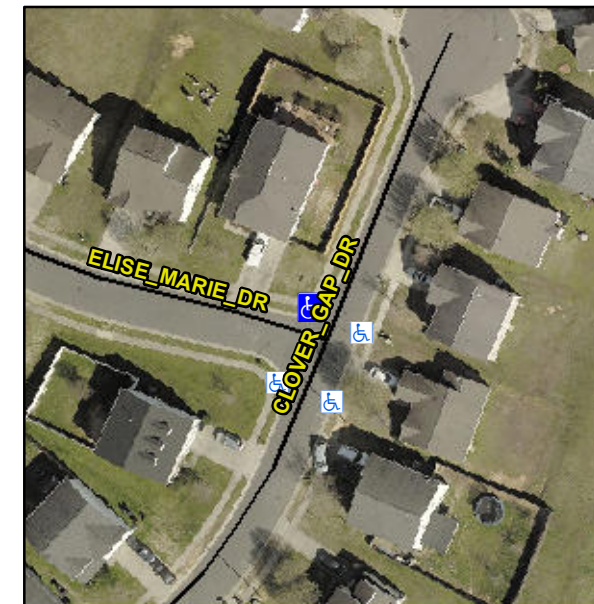
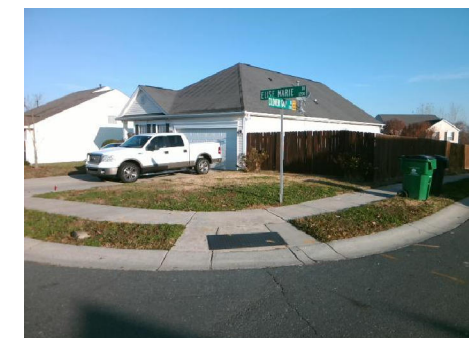
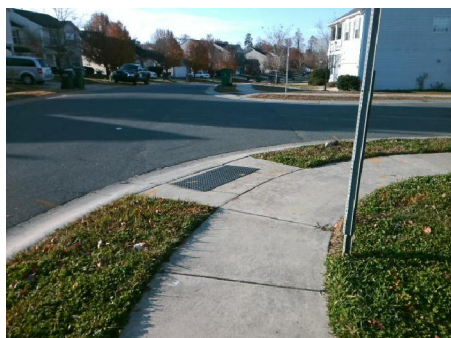
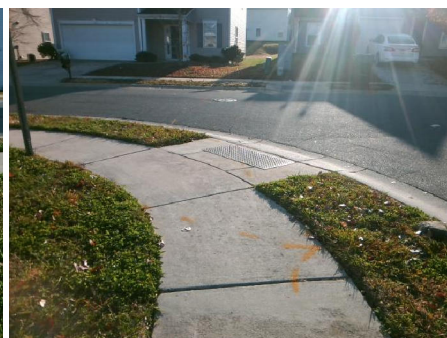
Compliance	Description	Data	Compliance	Description	Data
N/A	Ramp Length (in)	48.0	Yes	Ramp Slope (%)	6.5
No	Ramp Width (in)	34.0	Yes	Ramp XSlope (%)	0.1
N/A	Flare Type LT	N/A	N/A	Flare Type RT	N/A
N/A	Flare Slope LT (%)	N/A	N/A	Flare Slope RT (%)	N/A
N/A	Flare Traversable LT?	N/A	N/A	Flare Traversable RT?	N/A
N/A	Landing Length (in)	N/A	N/A	DWS Provided?	N/A
N/A	Landing Width (in)	N/A	N/A	DWS Contrast?	N/A
N/A	Landing Slope (%)	N/A	N/A	DWS Length (in)	N/A
N/A	Landing X Slope (%)	N/A	N/A	DWS Full Width?	N/A
N/A	Landing Curb? (Y/N)	N/A	N/A	DWS Offset (in)	N/A
N/A	Shared Landing?	N/A			
N/A	Gutter Ponding?	N/A	N/A	Gutter Slope (%)	N/A
N/A	Gutter Lip Ht (in)	N/A	N/A	Gutter X Slope (%)	N/A
N/A	Painted X Walk1?	No	N/A	Painted X Walk2?	No
	X Walk 1 Direction	To SW		X Walk 2 Direction	To SE
N/A	X Walk 1 Width (in)	N/A	N/A	X Walk 2 Width (in)	N/A
	X Walk 1 Slope (%)	3.6		X Walk 2 Slope (%)	4.9
	X Walk 1 X Slope (%)	3.6		X Walk 2 X Slope (%)	1.3

N/A	Ramp inside XWalk1?	N/A	N/A	Ramp inside XWalk2?	N/A
	Road Slope (%)	1.6	N/A	Clear Space?	N/A
	Road X Slope (%)	4.7	N/A	Clear Space to XWalk (in)	N/A
N/A	Any Obstructions?	N/A	N/A	Storm Grate/Utility Hazard?	N/A
	Obstruction Type			Storm Grate/Utility Type	
		N/A			N/A
			Yes	Surface Condition? (G/P)	Good

**Remove & Replace Curb Ramp With Two New Directional Ramps or Equivalent.**

**Not Found, R304.5.1**
