Access Compliance Report

Public Rights-of-Way

(Curb Ramps)

Intersection ID: N/A	Main Street: YORK_CENTER	Cross Street: N/A	Location: NW
ADA ID: 1C67F10B10B3	Ramp Type: Perp	Initial Pass/Fail: Fail	Overall Compliance: No
Severity Score: 13.75			
Codes/Mitigation Info/Possible Solution		Field Measurements/Component Compliance

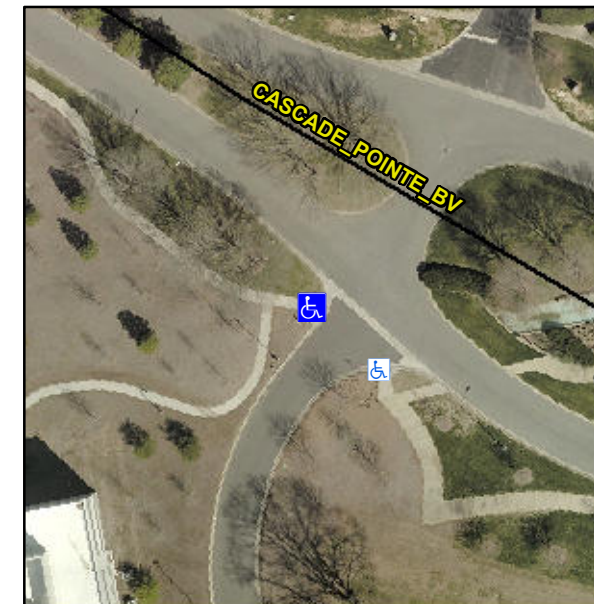
Not Found, R304.2.2, R304.5.3

Compliance	Description	Data	Compliance	Description	Data
N/A	Ramp Length (in)	74.0	No	Ramp Slope (%)	8.7
Yes	Ramp Width (in)	72.0	No	Ramp XSlope (%)	2.3
N/A	Flare Type LT	N/A	N/A	Flare Type RT	N/A
N/A	Flare Slope LT (%)	N/A	N/A	Flare Slope RT (%)	N/A
N/A	Flare Traversable LT?	N/A	N/A	Flare Traversable RT?	N/A
N/A	Landing Length (in)	N/A	N/A	DWS Provided?	N/A
N/A	Landing Width (in)	N/A	N/A	DWS Contrast?	N/A
N/A	Landing Slope (%)	N/A	N/A	DWS Length (in)	N/A
N/A	Landing X Slope (%)	N/A	N/A	DWS Full Width?	N/A
N/A	Landing Curb? (Y/N)	N/A	N/A	DWS Offset (in)	N/A
N/A	Shared Landing?	N/A			
N/A	Gutter Ponding?	N/A	N/A	Gutter Slope (%)	N/A
N/A	Gutter Lip Ht (in)	N/A	N/A	Gutter X Slope (%)	N/A
N/A	Painted X Walk1?	No	N/A	Painted X Walk2?	N/A
	X Walk 1 Direction	To S		X Walk 2 Direction	N/A
N/A	X Walk 1 Width (in)	N/A	N/A	X Walk 2 Width (in)	N/A
	X Walk 1 Slope (%)	1.5		X Walk 2 Slope (%)	N/A
	X Walk 1 X Slope (%)	1.7		X Walk 2 X Slope (%)	N/A

N/A	Ramp inside XWalk1?	N/A	N/A	Ramp inside XWalk2?	N/A
	Road Slope (%)	N/A	N/A	Clear Space?	N/A
	Road X Slope (%)	N/A	N/A	Clear Space to XWalk (in)	N/A
N/A	Any Obstructions?	N/A	N/A	Storm Grate/Utility Hazard?	N/A
	Obstruction Type			Storm Grate/Utility Type	
		N/A			N/A
			Yes	Surface Condition? (G/P)	Good

Remove & Replace Entire Ramp.
