Access Compliance Report

Public Rights-of-Way

(Curb Ramps)

Intersection ID: N/A	Main Street: PINE GLEN CT	Cross Street: N/A	Location: SE
ADA ID: 1C7346B09BAE	Ramp Type: Perp	Initial Pass/Fail: Pass	Overall Compliance: No
Severity Score: 5			
Codes/Mitigation Info/Possible Solution		Field Measurements/Component Compliance

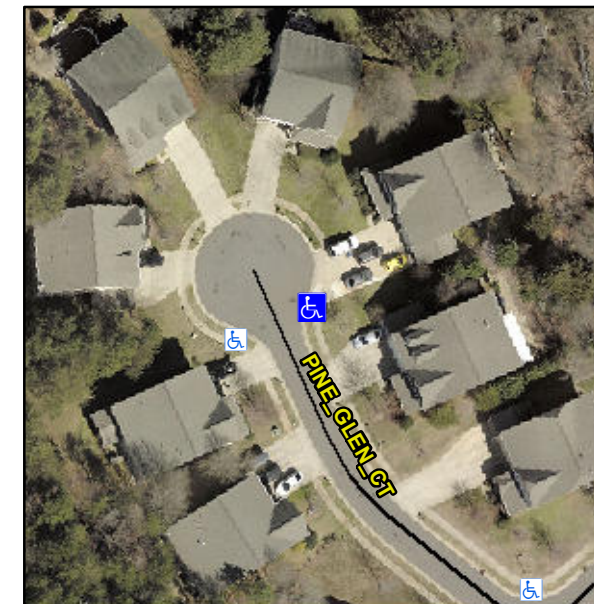
Compliance	Description	Data	Compliance	Description	Data
N/A	Ramp Length (in)	48.5	Yes	Ramp Slope (%)	7.8
Yes	Ramp Width (in)	48.0	Yes	Ramp XSlope (%)	0.4
N/A	Flare Type LT	Sloped	N/A	Flare Type RT	N/A
N/A	Flare Slope LT (%)	2.7	Yes	Flare Slope RT (%)	2.2
N/A	Flare Traversable LT?	Yes	N/A	Flare Traversable RT?	Yes
Yes	Landing Length (in)	48.0	Yes	DWS Provided?	Yes
Yes	Landing Width (in)	48.0	Yes	DWS Contrast?	Yes
No	Landing Slope (%)	3.6	Yes	DWS Length (in)	24.5
Yes	Landing X Slope (%)	1.1	Yes	DWS Full Width?	Yes
N/A	Landing Curb? (Y/N)	No	No	DWS Offset (in)	4.0
N/A	Shared Landing?	No			
Yes	Gutter Ponding?	No	No	Gutter Slope (%)	8.3
Yes	Gutter Lip Ht (in)	0.0	Yes	Gutter X Slope (%)	0.2
N/A	Painted X Walk1?	No	N/A	Painted X Walk2?	N/A
	X Walk 1 Direction	To SW		X Walk 2 Direction	N/A
N/A	X Walk 1 Width (in)	N/A	N/A	X Walk 2 Width (in)	N/A
	X Walk 1 Slope (%)	2.9		X Walk 2 Slope (%)	N/A
	X Walk 1 X Slope (%)	1.0		X Walk 2 X Slope (%)	N/A

N/A	Ramp inside XWalk1?	N/A	N/A	Ramp inside XWalk2?	N/A
	Road Slope (%)	N/A	N/A	Clear Space?	Yes
	Road X Slope (%)	N/A	N/A	Clear Space to XWalk (in)	N/A
Yes	Any Obstructions?	No	Yes	Storm Grate/Utility Hazard?	No
	Obstruction Type			Storm Grate/Utility Type	
		N/A			N/A
			Yes	Surface Condition? (G/P)	Good

**Remove & Replace Entire Ramp.
Remove & Replace Gutter.**
