Access Compliance Report

Public Rights-of-Way

(Curb Ramps)

Intersection ID: 14714	Main Street: E_MOREHEAD_ST	Cross Street: HARDING_PL	Location: N
ADA ID: 1C78F4DB8891	Ramp Type: PerpDiag	Initial Pass/Fail: Fail	Overall Compliance: No
			Severity Score: 13.75

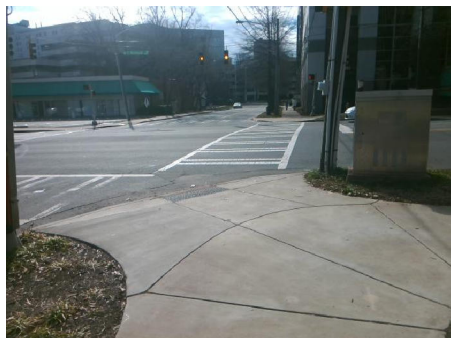
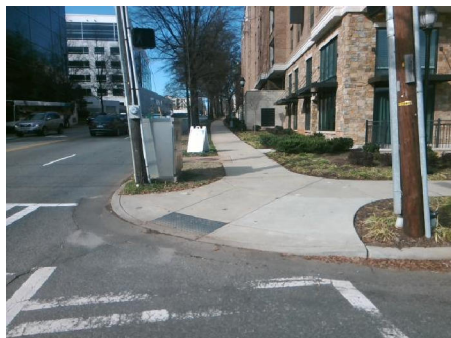
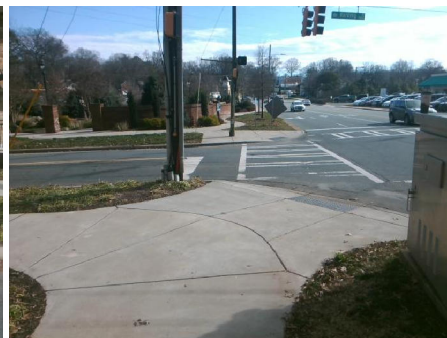
Not Found, R304.2.2

Compliance	Description	Data	Compliance	Description	Data
N/A	Ramp Length (in)	96.0	No	Ramp Slope (%)	8.5
Yes	Ramp Width (in)	48.0	Yes	Ramp XSlope (%)	2.7
N/A	Flare Type LT	N/A	N/A	Flare Type RT	N/A
N/A	Flare Slope LT (%)	N/A	N/A	Flare Slope RT (%)	N/A
N/A	Flare Traversable LT?	N/A	N/A	Flare Traversable RT?	N/A
N/A	Landing Length (in)	N/A	N/A	DWS Provided?	N/A
N/A	Landing Width (in)	N/A	N/A	DWS Contrast?	N/A
N/A	Landing Slope (%)	N/A	N/A	DWS Length (in)	N/A
N/A	Landing X Slope (%)	N/A	N/A	DWS Full Width?	N/A
N/A	Landing Curb? (Y/N)	N/A	N/A	DWS Offset (in)	N/A
N/A	Shared Landing?	N/A			
N/A	Gutter Ponding?	N/A	N/A	Gutter Slope (%)	N/A
N/A	Gutter Lip Ht (in)	N/A	N/A	Gutter X Slope (%)	N/A
N/A	Painted X Walk1?	Yes	N/A	Painted X Walk2?	Yes
	X Walk 1 Direction	To SW		X Walk 2 Direction	To SE
N/A	X Walk 1 Width (in)	108.0	N/A	X Walk 2 Width (in)	114.0
	X Walk 1 Slope (%)	3.5		X Walk 2 Slope (%)	0.5
	X Walk 1 X Slope (%)	2.7		X Walk 2 X Slope (%)	1.0

N/A	Ramp inside XWalk1?	Yes	N/A	Ramp inside XWalk2?	Yes
	Road Slope (%)	3.0	N/A	Clear Space?	N/A
	Road X Slope (%)	0.6	N/A	Clear Space to XWalk (in)	N/A
N/A	Any Obstructions?	N/A	N/A	Storm Grate/Utility Hazard?	N/A
	Obstruction Type			Storm Grate/Utility Type	
		N/A			N/A
		Yes		Surface Condition? (G/P)	Good

Remove & Replace Curb Ramp With Two New Directional Ramps or Equivalent.
