Access Compliance Report

Public Rights-of-Way

(Curb Ramps)

Intersection ID: 15915	Main Street: MARNEY_AV	Cross Street: STANCILL_PL	Location:	N
ADA ID: 1C838AD5AC4C	Ramp Type: Para	Initial Pass/Fail: Pass	Overall Compliance: No	Severity Score: 5.25
Codes/Mitigation Info/Possible Solution		Field Measurements/Component Compliance

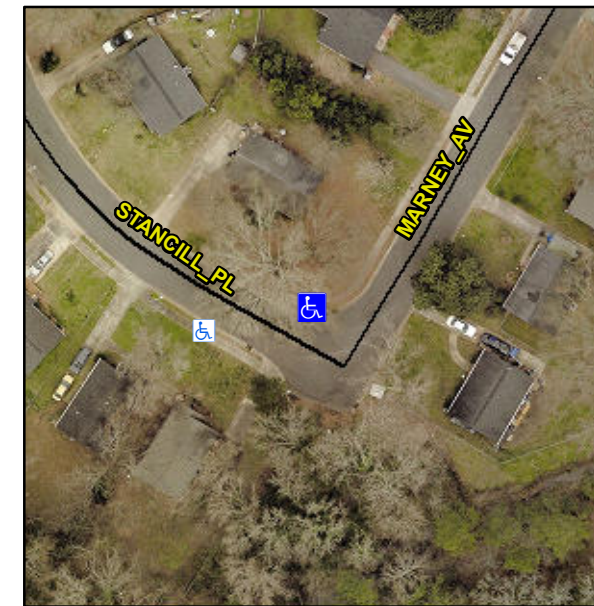
RT RP < 5%

R304.5.3, R304.2.1, R304.5.4

Compliance	Description	Data	Compliance	Description	Data
N/A	Ramp Length LT (in)	27.0	N/A	Ramp Length RT (in)	26.0
Yes	Ramp Width LT (in)	60.0	Yes	Ramp Width RT (in)	60.0
Yes	Ramp Slope LT (%)	5.5	Yes	Ramp Slope RT (%)	0.9
No	Ramp XSlope LT (%)	3.0	Yes	Ramp XSlope RT (%)	1.6
Yes	Landing Length (in)	83.0	Yes	DWS Provided?	Yes
No	Landing Width (in)	47.5	Yes	DWS Contrast?	Yes
Yes	Landing Slope (%)	2.0	Yes	DWS Length (in)	24.0
No	Landing X Slope (%)	12.4	Yes	DWS Full Width?	Yes
N/A	Landing Curb? (Y/N)	No	Yes	DWS Offset (in)	1.0
N/A	Shared Landing?	No			
Yes	Gutter Ponding?	No	No	Gutter Slope (%)	10.1
Yes	Gutter Lip Ht (in)	0.0	No	Gutter X Slope (%)	3.9
N/A	Painted X Walk1?	No	N/A	Painted X Walk2?	N/A
	X Walk 1 Direction	To S		X Walk 2 Direction	N/A
N/A	X Walk 1 Width (in)	N/A	N/A	X Walk 2 Width (in)	N/A
	X Walk 1 Slope (%)	6.0		X Walk 2 Slope (%)	N/A
	X Walk 1 X Slope (%)	3.0		X Walk 2 X Slope (%)	N/A
N/A	Ramp inside XWalk1?	N/A	N/A	Ramp inside XWalk2?	N/A

Road Slope (%)	N/A	N/A	Clear Space?	Yes
	Road X Slope (%)	N/A	N/A	Clear Space to XWalk (in)	N/A
Yes	Any Obstructions?	No	Yes	Storm Grate/Utility Hazard?	No
	Obstruction Type			Storm Grate/Utility Type	
		N/A			N/A
			Yes	Surface Condition? (G/P)	Good
			N/A	Curb Slope (%)	15.3

Possible Solutions:

**Remove & Replace Entire Ramp.
Remove & Replace Gutter.**
