# Access Compliance Report

## Public Rights-of-Way

### (Curb Ramps)

Intersection ID: 47135	Main Street: SARANAC_LN	Cross Street: FIELDSTONE_MANOR_DR	Location: N
ADA ID: 1C87066153B0	Ramp Type: PerpDiag	Initial Pass/Fail: Fail	Overall Compliance: No
Severity Score: 47.5			
Codes/Mitigation Info/Possible Solution		Field Measurements/Component Compliance

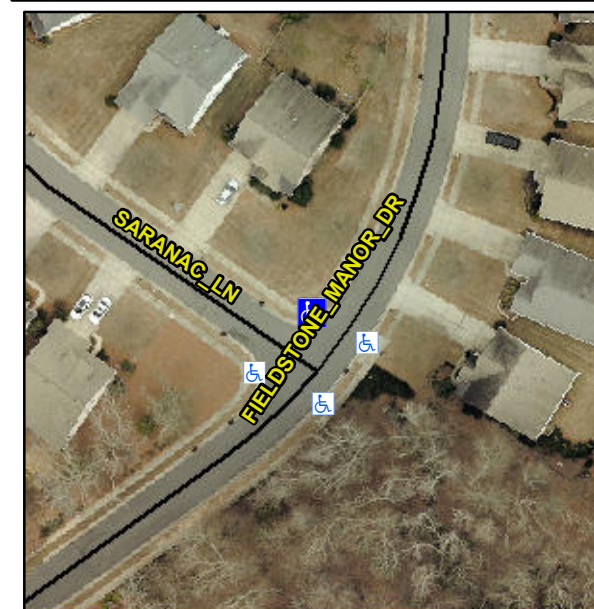
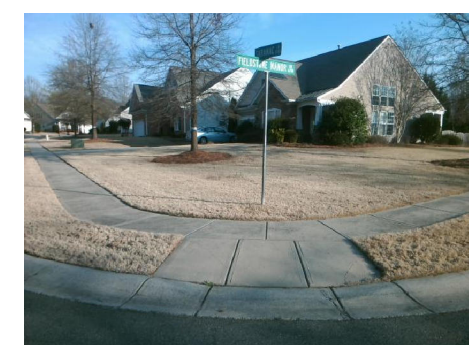
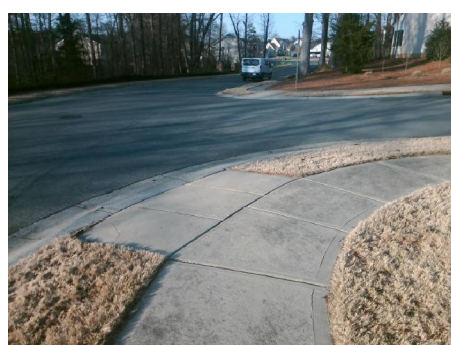
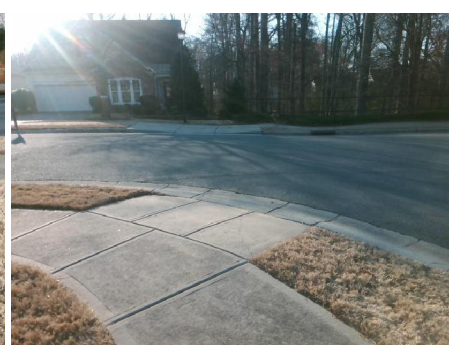
Compliance	Description	Data	Compliance	Description	Data
N/A	Ramp Length (in)	51.0	No	Ramp Slope (%)	11.1
No	Ramp Width (in)	30.0	Yes	Ramp XSlope (%)	0.5
N/A	Flare Type LT	N/A	N/A	Flare Type RT	N/A
N/A	Flare Slope LT (%)	N/A	N/A	Flare Slope RT (%)	N/A
N/A	Flare Traversable LT?	N/A	N/A	Flare Traversable RT?	N/A
N/A	Landing Length (in)	N/A	N/A	DWS Provided?	N/A
N/A	Landing Width (in)	N/A	N/A	DWS Contrast?	N/A
N/A	Landing Slope (%)	N/A	N/A	DWS Length (in)	N/A
N/A	Landing X Slope (%)	N/A	N/A	DWS Full Width?	N/A
N/A	Landing Curb? (Y/N)	N/A	N/A	DWS Offset (in)	N/A
N/A	Shared Landing?	N/A			
N/A	Gutter Ponding?	N/A	N/A	Gutter Slope (%)	N/A
N/A	Gutter Lip Ht (in)	N/A	N/A	Gutter X Slope (%)	N/A
N/A	Painted X Walk1?	No	N/A	Painted X Walk2?	No
	X Walk 1 Direction	To SW		X Walk 2 Direction	To SE
N/A	X Walk 1 Width (in)	N/A	N/A	X Walk 2 Width (in)	N/A
	X Walk 1 Slope (%)	1.9		X Walk 2 Slope (%)	2.5
	X Walk 1 X Slope (%)	0.4		X Walk 2 X Slope (%)	0.2

N/A	Ramp inside XWalk1?	N/A	N/A	Ramp inside XWalk2?	N/A
	Road Slope (%)	1.4	N/A	Clear Space?	N/A
	Road X Slope (%)	1.0	N/A	Clear Space to XWalk (in)	N/A
N/A	Any Obstructions?	N/A	N/A	Storm Grate/Utility Hazard?	N/A
	Obstruction Type			Storm Grate/Utility Type	
		N/A			N/A
		Yes		Surface Condition? (G/P)	Good

**Remove & Replace Curb Ramp With Two New Directional Ramps or Equivalent.**

**R304.5.1, R304.2.2**
