Access Compliance Report

Public Rights-of-Way

(Curb Ramps)

| Intersection ID: 23966 | Main Street: CAROLINA_PAVILION_DR_N | Cross Street: SOUTH_BV | Location: SE |

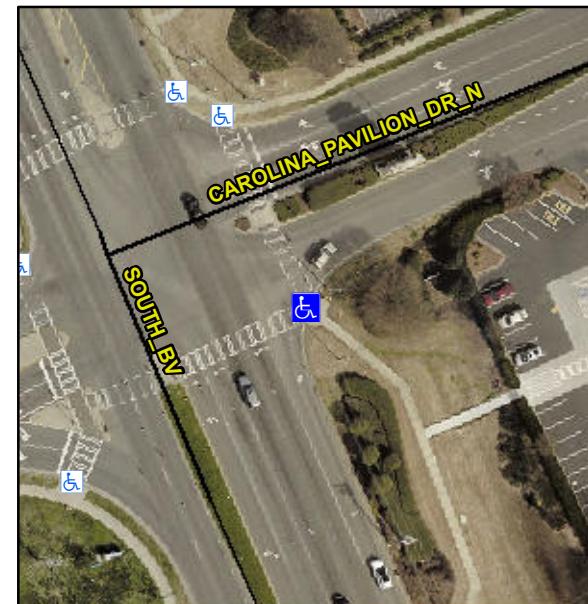
| ADA ID: 1C8B85CDBA80 | Ramp Type: PerpDiag | Initial Pass/Fail: Pass | Overall Compliance: No |
| Severity Score: 2.5 | | | |

Not Found, R304.2.1, R304.2.2-Perp, R304.3.2-Para, R305.1.4, R305.2

| Compliance | Description | Data | Compliance | Description | Data |
|---|---|---|---|---|---|
| No | Landing Length (in) | 42.0 | Yes | DWS Provided? | Yes |
| No | Landing Slope (%) | 3.2 | Yes | DWS Length (in) | 24.0 |
| Yes | Landing X Slope (%) | 0.6 | No | DWS Full Width? | No |
| N/A | Landing Curb? (Y/N) | No | No | DWS Offset (in) | 4.0 |

Remove & Replace Curb Ramp With Two New Directional Ramps or Equivalent.

Total Cost: \$ 3200.00
