## Access Compliance Report Public Rights-of-Way (Curb Ramps)

Intersection ID: 27192 Main Street: MCKEE\_RD Cross Street: TILLEY\_MORRIS\_RD Location: SW

ADA ID: 1C97DEFC85F0 Ramp Type: Perp Initial Pass/Fail: Pass Overall Compliance: No Severity Score: 25

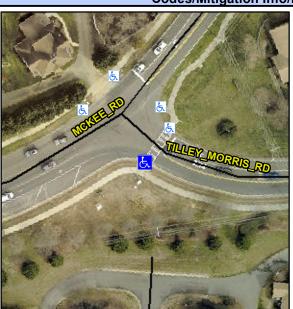
PROW/ADA:
Not Found, R305, R302.7.2, R304.5.3

Compliance Description Data Compliance Description Yes N/A Ramp Length (in) 95.0 Ramp Slope (%) Yes Ramp XSlope (%) Yes Ramp Width (in) 54.0 N/A Flare Type LT Sloped N/A Flare Type RT N/A 4.7 Yes Flare Slope RT (%) Flare Slope LT (%) N/A Flare Traversable LT? Yes N/A Flare Traversable RT? Yes 72.0 No DWS Provided? Landing Length (in) Yes Landing Width (in) 54.0 N/A **DWS Contrast?** 0.8 N/A Yes Landing Slope (%) DWS Length (in) N/A Yes Landing X Slope (%) 0.7 DWS Full Width? N/A Landing Curb? (Y/N) No N/A DWS Offset (in) N/A Shared Landing? No **Gutter Ponding?** No Yes Gutter Slope (%) Yes No Gutter Lip Ht (in) 1.0 No Gutter X Slope (%) N/A Painted X Walk1? Yes N/A Painted X Walk2? X Walk 1 Direction To NE X Walk 2 Direction N/A 108.0 X Walk 2 Width (in) X Walk 1 Width (in) X Walk 1 Slope (%) 0.8 X Walk 2 Slope (%) X Walk 1 X Slope (%) 0.8 X Walk 2 X Slope (%) N/A Ramp inside XWalk2? Yes Ramp inside XWalk1? Yes Road Slope (%) N/A N/A Clear Space? Road X Slope (%) N/A N/A Clear Space to XWalk (in) No Yes Any Obstructions? Yes Storm Grate/Utility Hazard? **Obstruction Type** Storm Grate/Utility Type

Remove & Replace Entire Ramp.
Remove & Replace Gutter.
