Access Compliance Report

Public Rights-of-Way

(Curb Ramps)

| Intersection ID: 6829 | Main Street: PRINCESS_ST | Cross Street: W_SUGAR_CREEK_RD | Location: W |

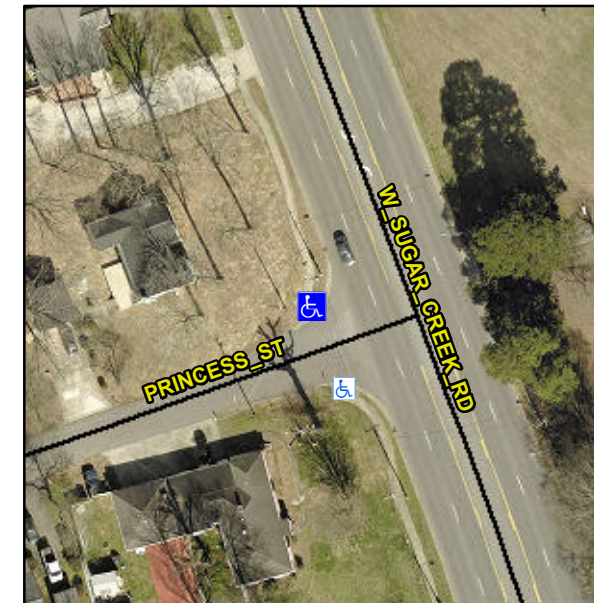
GTR GAP 2.0, RT RP < 5%

Not Found, R304.5.1, R304.5.3

| Compliance | Description | Data | Compliance | Description | Data |
|---|---|---|---|---|---|
| No | Ramp XSlope LT (%) | 3.8 | No | Ramp XSlope RT (%) | 3.1 |
| No | Ramp Width (in) | 44.0 | Yes | Ramp XSlope (%) | 1.7 |

Remove & Replace Entire Ramp.
