Access Compliance Report

Public Rights-of-Way

(Curb Ramps)

Intersection ID: 11424	Main Street: GLENVILLE_AV	Cross Street: STONEHAVEN_DR	Location: SE
ADA ID: 1CA2010B07C5	Ramp Type: BlendTrans1	Initial Pass/Fail: Fail	Overall Compliance: No
		Severity Score: 10

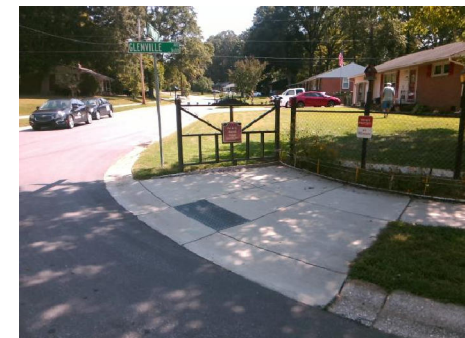
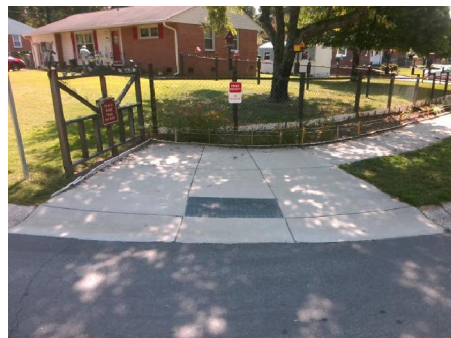
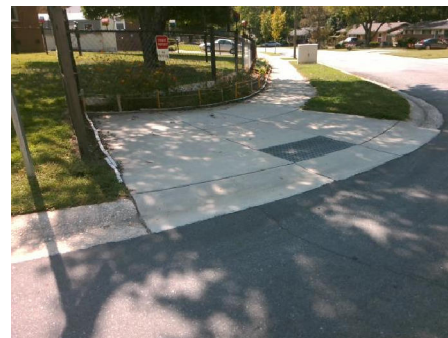
Not Found, R304.5.1, R304.5.3

Compliance	Description	Data	Compliance	Description	Data
N/A	Ramp Length (in)	72.0	Yes	BlendTrans Slope (%)	3.0
No	Ramp Width (in)	42.5	No	BlendTrans XSlope (%)	4.5
N/A	Flare Type LT	N/A	N/A	Flare Type RT	N/A
N/A	Flare Slope LT (%)	N/A	N/A	Flare Slope RT (%)	N/A
N/A	Flare Traversable LT?	N/A	N/A	Flare Traversable RT?	N/A
N/A	Landing Length (in)	N/A	N/A	DWS Provided?	N/A
N/A	Landing Width (in)	N/A	N/A	DWS Contrast?	N/A
N/A	Landing Slope (%)	N/A	N/A	DWS Length (in)	N/A
N/A	Landing X Slope (%)	N/A	N/A	DWS Full Width?	N/A
N/A	Landing Curb? (Y/N)	N/A	N/A	DWS Offset (in)	N/A
N/A	Shared Landing?	N/A			
N/A	Gutter Ponding?	N/A	N/A	Gutter Slope (%)	N/A
N/A	Gutter Lip Ht (in)	N/A	N/A	Gutter X Slope (%)	N/A
N/A	Painted X Walk1?	No	N/A	Painted X Walk2?	N/A
	X Walk 1 Direction	To N		X Walk 2 Direction	N/A
	X Walk 1 Width (in)	N/A		X Walk 2 Width (in)	N/A
	X Walk 1 Slope (%)	3.0		X Walk 2 Slope (%)	N/A
	X Walk 1 X Slope (%)	4.5		X Walk 2 X Slope (%)	N/A

N/A	Ramp inside XWalk1?	N/A	N/A	Ramp inside XWalk2?	N/A
	Road Slope (%)	4.5		Clear Space?	N/A
	Road X Slope (%)	3.0	N/A	Clear Space to XWalk (in)	N/A
N/A	Any Obstructions?	N/A	N/A	Storm Grate/Utility Hazard?	N/A
	Obstruction Type			Storm Grate/Utility Type	
		N/A			N/A
			Yes	Surface Condition? (G/P)	Good
			No	Curb Slope (%)	14.2

Remove & Replace Curb Ramp With Two New Directional Ramps or Equivalent.
