## Access Compliance Report Public Rights-of-Way (Curb Ramps)

Intersection ID: 4530 Main Street: BROOKSHIRE\_BV Cross Street: MT\_HOLLY-HUNTERSVILLE\_RD Location: SW

ADA ID: 1CA7765B38A9 Ramp Type: BlendTrans1 Initial Pass/Fail: Fail Overall Compliance: No Severity Score: 8.75

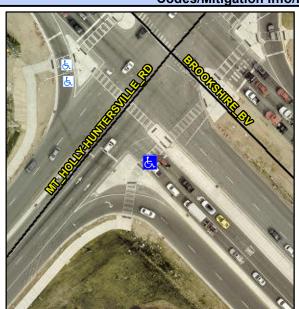
Comp	liance Description	Data	Comp	liance Description	Data
N/A	Ramp Length (in)	60.5	Yes	BlendTrans Slope (%)	4.2
No	Ramp Width (in)	46.0	Yes	BlendTrans XSlope (%)	1.9
N/A	Flare Type LT	N/A	N/A	Flare Type RT	N/A
N/A	Flare Slope LT (%)	N/A	N/A	Flare Slope RT (%)	N/A
N/A	Flare Traversable LT?	N/A	N/A	Flare Traversable RT?	N/A
N/A	Landing Length (in)	N/A	N/A	DWS Provided?	N/A
N/A	Landing Width (in)	N/A	N/A	DWS Contrast?	N/A
N/A	Landing Slope (%)	N/A	N/A	DWS Length (in)	N/A
N/A	Landing X Slope (%)	N/A	N/A	DWS Full Width?	N/A
N/A	Landing Curb? (Y/N)	N/A	N/A	DWS Offset (in)	N/A
N/A	Shared Landing?	N/A			
N/A	Gutter Ponding?	N/A	N/A	Gutter Slope (%)	N/A
N/A	Gutter Lip Ht (in)	N/A	N/A	Gutter X Slope (%)	N/A
N/A	Painted X Walk1?	Yes	N/A	Painted X Walk2?	N/A
	X Walk 1 Direction	To NW		X Walk 2 Direction	N/A
	X Walk 1 Width (in)	112.0		X Walk 2 Width (in)	N/A
	X Walk 1 Slope (%)	0.1		X Walk 2 Slope (%)	N/A
	X Walk 1 X Slope (%)	1.2		X Walk 2 X Slope (%)	N/A

N/A	Ramp inside XWalk1?	Yes	N/A	Ramp inside XWalk2?	N/A
	Road Slope (%)	1.2		Clear Space?	N/A
	Road X Slope (%)	0.1	N/A	Clear Space to XWalk (in)	N/A
N/A	Any Obstructions?	N/A	N/A	Storm Grate/Utility Hazard?	N/A
	Obstruction Type			Storm Grate/Utility Type	
		N/A			N/A
			Yes	Surface Condition? (G/P)	Good

Remove & Replace Curb Ramp With
Two New Directional Ramps or
Equivalent.

R304.5.1
