Access Compliance Report

Public Rights-of-Way

(Curb Ramps)

Intersection ID: 10000	Main Street: FONTANA_AV	Cross Street: WHISNANT_ST	Location: NE
ADA ID: 1CB4AC59D835	Ramp Type: Combination2	Initial Pass/Fail: Fail	Overall Compliance: No
		Severity Score: 22.5

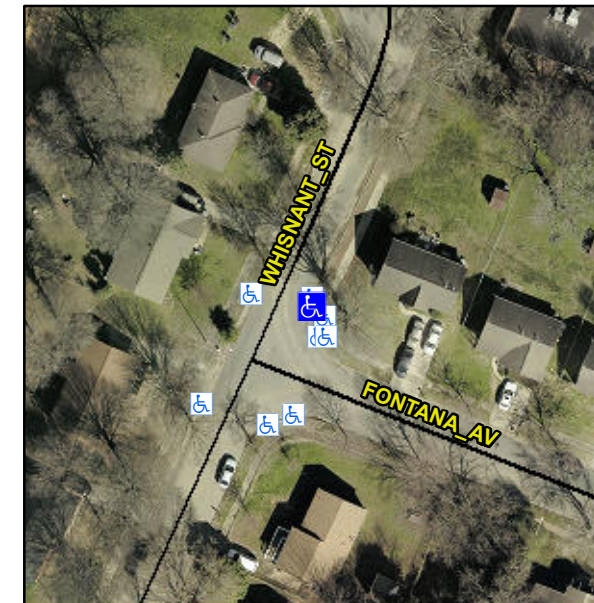
RT RP < 5%

Not Found, R304.5.1, R304.5.3, R304.3.2

Compliance	Description	Data	Compliance	Description	Data
N/A	Ramp Length LT (in)	30.0	N/A	Ramp Length RT (in)	47.0
Yes	Ramp Width LT (in)	60.0	N/A	Ramp Width RT (in)	53.0
No	Ramp Slope LT (%)	8.9	N/A	Ramp Slope RT (%)	3.3
No	Ramp XSlope LT (%)	3.6	N/A	Ramp XSlope RT (%)	2.8
N/A	Ramp Length (in)	51.5	Yes	Ramp Slope (%)	5.0
No	Ramp Width (in)	44.0	No	Ramp XSlope (%)	2.2
N/A	Flare Type LT	N/A	N/A	Flare Type RT	N/A
N/A	Flare Slope LT (%)	N/A	N/A	Flare Slope RT (%)	N/A
N/A	Flare Traversable LT?	N/A	N/A	Flare Traversable RT?	N/A
N/A	Landing Length (in)	N/A	N/A	DWS Provided?	N/A
N/A	Landing Width (in)	N/A	N/A	DWS Contrast?	N/A
N/A	Landing Slope (%)	N/A	N/A	DWS Length (in)	N/A
N/A	Landing X Slope (%)	N/A	N/A	DWS Full Width?	N/A
N/A	Landing Curb? (Y/N)	N/A	N/A	DWS Offset (in)	N/A
N/A	Shared Landing?	N/A			
N/A	Gutter Ponding?	N/A	N/A	Gutter Slope (%)	N/A
N/A	Gutter Lip Ht (in)	N/A	N/A	Gutter X Slope (%)	N/A
N/A	Painted X Walk1?	No	N/A	Painted X Walk2?	N/A

X Walk 1 Direction	To W		X Walk 2 Direction	N/A
	X Walk 1 Width (in)	N/A		X Walk 2 Width (in)	N/A
	X Walk 1 Slope (%)	3.3		X Walk 2 Slope (%)	N/A
	X Walk 1 X Slope (%)	0.4		X Walk 2 X Slope (%)	N/A
N/A	Ramp inside XWalk1?	N/A	N/A	Ramp inside XWalk2?	N/A
	Road Slope (%)	N/A		Clear Space?	N/A
	Road X Slope (%)	N/A	N/A	Clear Space to XWalk (in)	N/A
			N/A	Any Obstruction?	N/A
				Obstruction Type	N/A
			N/A	Storm Grate/Utility Hazard?	N/A
				Storm Grate/Utility Type	N/A
			Yes	Surface Condition? (G/P)	Good
				Curb Slope (%)	19.6

Remove & Replace Entire Ramp.
