Access Compliance Report

Public Rights-of-Way

(Curb Ramps)

Intersection ID: N/A	Main Street: BRECKFIELD_CT	Cross Street: SHETLAND_LN	Location: NE
ADA ID: 1CBDEF4263A3	Ramp Type: PerpDiag	Initial Pass/Fail: Fail	Overall Compliance: No
Codes/Mitigation Info/Possible Solution		Field Measurements/Component Compliance

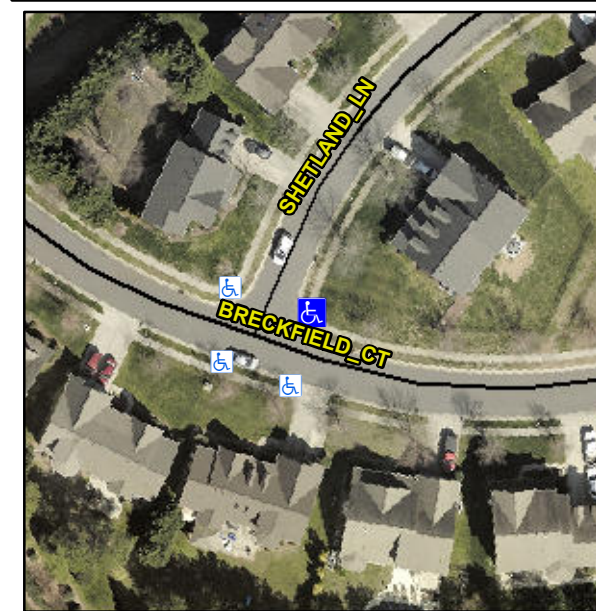
Not Found, R304.2.2, R304.5.3

Compliance	Description	Data	Compliance	Description	Data
N/A	Ramp Length (in)	45.0	No	Ramp Slope (%)	12.2
Yes	Ramp Width (in)	48.0	No	Ramp XSlope (%)	2.2
N/A	Flare Type LT	N/A	N/A	Flare Type RT	N/A
N/A	Flare Slope LT (%)	N/A	N/A	Flare Slope RT (%)	N/A
N/A	Flare Traversable LT?	N/A	N/A	Flare Traversable RT?	N/A
N/A	Landing Length (in)	N/A	N/A	DWS Provided?	N/A
N/A	Landing Width (in)	N/A	N/A	DWS Contrast?	N/A
N/A	Landing Slope (%)	N/A	N/A	DWS Length (in)	N/A
N/A	Landing X Slope (%)	N/A	N/A	DWS Full Width?	N/A
N/A	Landing Curb? (Y/N)	N/A	N/A	DWS Offset (in)	N/A
N/A	Shared Landing?	N/A			
N/A	Gutter Ponding?	N/A	N/A	Gutter Slope (%)	N/A
N/A	Gutter Lip Ht (in)	N/A	N/A	Gutter X Slope (%)	N/A
N/A	Painted X Walk1?	No	N/A	Painted X Walk2?	No
	X Walk 1 Direction	To NW		X Walk 2 Direction	To SW
N/A	X Walk 1 Width (in)	N/A	N/A	X Walk 2 Width (in)	N/A
	X Walk 1 Slope (%)	2.1		X Walk 2 Slope (%)	2.2
	X Walk 1 X Slope (%)	1.4		X Walk 2 X Slope (%)	1.0

N/A	Ramp inside XWalk1?	N/A	N/A	Ramp inside XWalk2?	N/A
	Road Slope (%)	1.2	N/A	Clear Space?	N/A
	Road X Slope (%)	0.6	N/A	Clear Space to XWalk (in)	N/A
N/A	Any Obstructions?	N/A	N/A	Storm Grate/Utility Hazard?	N/A
	Obstruction Type			Storm Grate/Utility Type	
		N/A			N/A
			Yes	Surface Condition? (G/P)	Good

Remove & Replace Curb Ramp With Two New Directional Ramps or Equivalent.
