Access Compliance Report

Public Rights-of-Way

(Curb Ramps)

Intersection ID: 29678	Main Street: CAMERON_CREEK_DR	Cross Street: WEDDINGTON_RIDGE_LN	Location:	N
ADA ID: 1CCA632CD921	Ramp Type: Perp	Initial Pass/Fail: Pass	Overall Compliance: No	Severity Score: 15

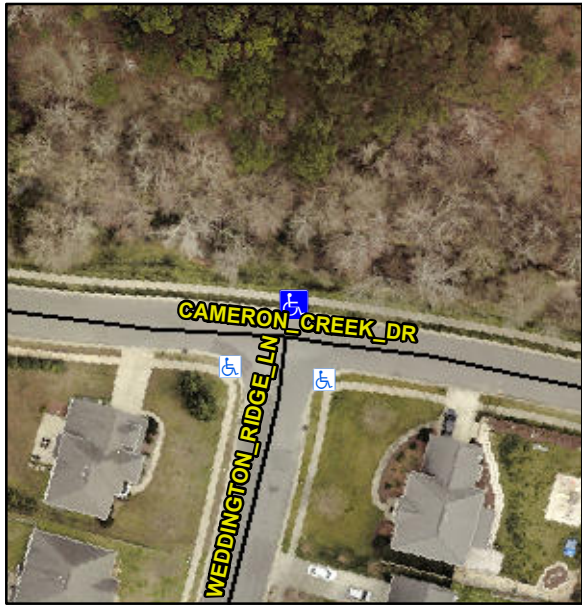
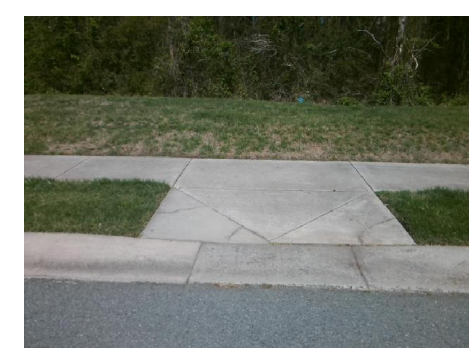
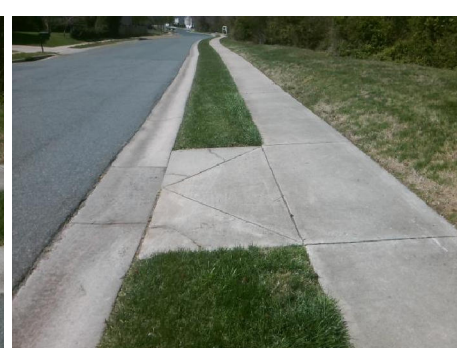
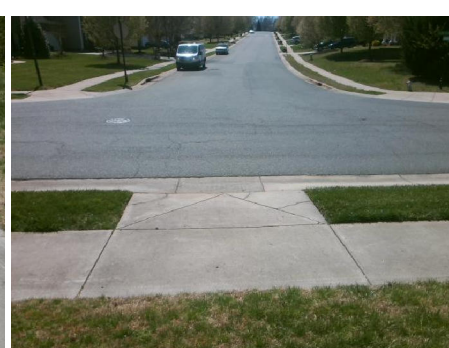
Possible Solutions:		Compliance	Description	Data	Compliance	Description	Data
	Remove & Replace Entire Ramp.		N/A	Ramp Length (in)	48.0	Yes	Ramp Slope (%)	5.6
	Remove & Replace Gutter.		Yes	Ramp Width (in)	51.0	Yes	Ramp XSlope (%)	0.3
			N/A	Flare Type LT	Sloped	N/A	Flare Type RT	N/A
			N/A	Flare Slope LT (%)	4.1	Yes	Flare Slope RT (%)	1.9
			N/A	Flare Traversable LT?	Yes	N/A	Flare Traversable RT?	Yes
			Yes	Landing Length (in)	48.0	No	DWS Provided?	No
			Yes	Landing Width (in)	51.0	N/A	DWS Contrast?	No
			No	Landing Slope (%)	5.4	N/A	DWS Length (in)	N/A
			No	Landing X Slope (%)	2.3	N/A	DWS Full Width?	No
Surveyor Notes:		N/A	N/A	Landing Curb? (Y/N)	No	N/A	DWS Offset (in)	N/A
PROW/ADA:		R304.2.2-Perp, R304.3.2-Para, R304.5.3, R305, R304.5.4	N/A	Shared Landing?	No			
			Yes	Gutter Ponding?	No	No	Gutter Slope (%)	9.9

Yes	Gutter Lip Ht (in)	0.0	Yes	Gutter X Slope (%)	1.7
			N/A	Painted X Walk1?	No	N/A	Painted X Walk2?	N/A
				X Walk 1 Direction	To S		X Walk 2 Direction	N/A
			N/A	X Walk 1 Width (in)	N/A	N/A	X Walk 2 Width (in)	N/A
				X Walk 1 Slope (%)	4.0		X Walk 2 Slope (%)	N/A
				X Walk 1 X Slope (%)	1.3		X Walk 2 X Slope (%)	N/A
			N/A	Ramp inside XWalk1?	N/A	N/A	Ramp inside XWalk2?	N/A
				Road Slope (%)	N/A	N/A	Clear Space?	Yes
				Road X Slope (%)	N/A	N/A	Clear Space to XWalk (in)	N/A
			Yes	Any Obstructions?	No	Yes	Storm Grate/Utility Hazard?	No
				Obstruction Type			Storm Grate/Utility Type	
						N/A		N/A
						Yes	Surface Condition? (G/P)	Good
Total Cost:		\$ 2600.00
