# Access Compliance Report

## Public Rights-of-Way

### (Curb Ramps)

Intersection ID: 21585	Main Street: BROOKFIELD_DR	Cross Street: LOVETT_CR	Location:	S
ADA ID: 1CCE9BE74002	Ramp Type: Directional1	Initial Pass/Fail: Fail	Overall Compliance: No	Severity Score: 8.75
Codes/Mitigation Info/Possible Solution		Field Measurements/Component Compliance

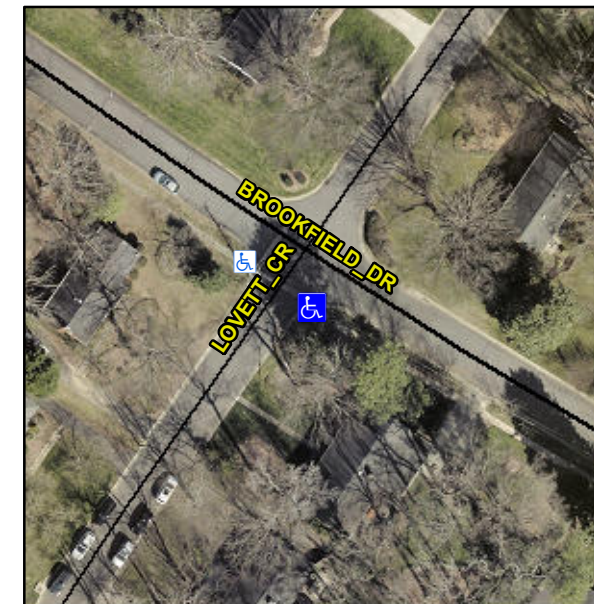
Compliance	Description	Data	Compliance	Description	Data
N/A	Ramp Length (in)	55.0	N/A	Grade Break?	N/A
No	Ramp Width (in)	46.0	N/A	Grade Break Slope (%)	0.0
Yes	Ramp Slope (%)	2.2	N/A	Grade Break XSlope (%)	0.0
Yes	Ramp XSlope (%)	0.3			
N/A	Flare Type LT	N/A	N/A	Flare Type RT	N/A
N/A	Flare Slope LT (%)	N/A	N/A	Flare Slope RT (%)	0.0
N/A	Flare Traversable LT?	N/A	N/A	Flare Traversable RT?	N/A
N/A	Landing Length (in)	0.0	N/A	DWS Provided?	N/A
N/A	Landing Width (in)	0.0	N/A	DWS Contrast?	N/A
N/A	Landing Slope (%)	0.0	N/A	DWS Length (in)	N/A
N/A	Landing X Slope (%)	0.0	N/A	DWS Full Width?	N/A
N/A	Landing Curb? (Y/N)	N/A	N/A	DWS Offset LT (in)	N/A
N/A	Shared Landing?	N/A	N/A	DWS Offset RT (in)	N/A
N/A	Gutter Ponding?	0.0	N/A	Gutter Slope (%)	N/A
N/A	Gutter Lip Ht (in)	0.0	N/A	Gutter X Slope (%)	N/A
N/A	Painted X Walk1?	No		Road Slope (%)	4.0
	X Walk 1 Direction	To W		Road X Slope (%)	5.2
	X Walk 1 Width (in)	N/A		Clear Space?	N/A

X Walk 1 Slope (%)	4.0	N/A	Clear Space to XWalk (in)	N/A
	X Walk 1 X Slope (%)	5.2	N/A	Storm Grate/Utility Hazard?	N/A
N/A	Ramp inside XWalk1?	N/A		Storm Grate/Utility Type	
N/A	Any Obstructions?	N/A			N/A
	Obstruction Type		Yes	Surface Condition? (G/P)	Good
			N/A	Curb Slope (%)	18.8

Possible Solutions:

**Remove & Replace Entire Ramp.**
