Access Compliance Report

Public Rights-of-Way

(Curb Ramps)

Intersection ID: 10024638	Main Street: DARLINGTON_RD	Cross Street: N/A	Location: SE
ADA ID: 1CE017E1D98A	Ramp Type: Perp	Initial Pass/Fail: Fail	Overall Compliance: No
Severity Score: 10			
Codes/Mitigation Info/Possible Solution		Field Measurements/Component Compliance

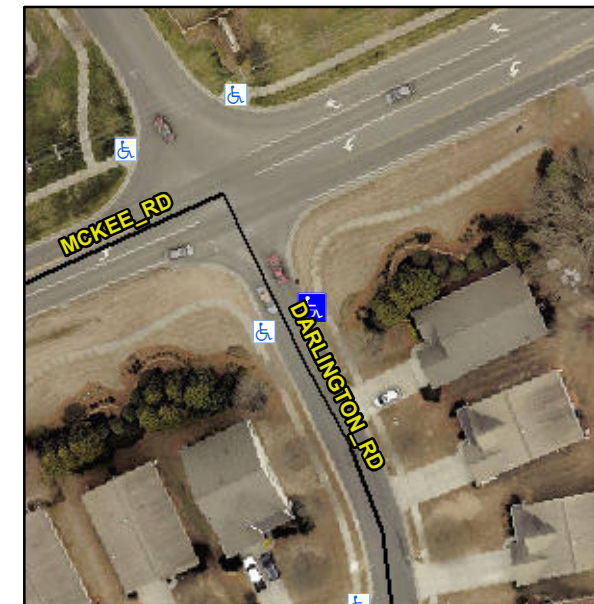
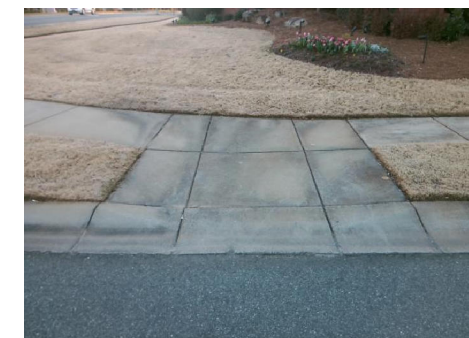
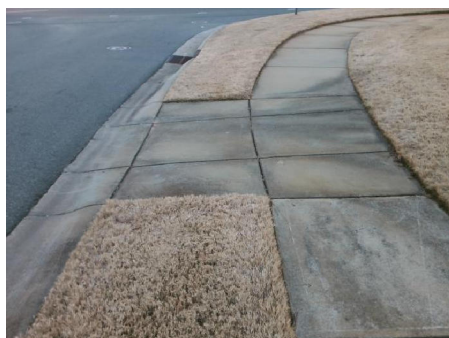
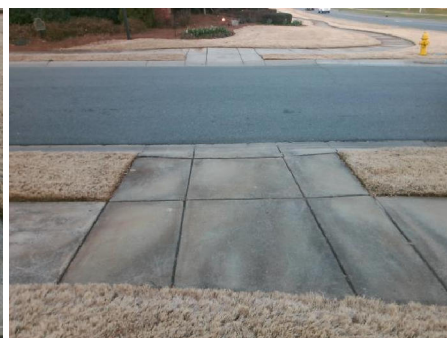
Not Found, R304.5.1, R304.5.3

Compliance	Description	Data	Compliance	Description	Data
N/A	Ramp Length (in)	48.0	Yes	Ramp Slope (%)	5.2
No	Ramp Width (in)	47.0	No	Ramp XSlope (%)	2.6
N/A	Flare Type LT	N/A	N/A	Flare Type RT	N/A
N/A	Flare Slope LT (%)	N/A	N/A	Flare Slope RT (%)	N/A
N/A	Flare Traversable LT?	N/A	N/A	Flare Traversable RT?	N/A
N/A	Landing Length (in)	N/A	N/A	DWS Provided?	N/A
N/A	Landing Width (in)	N/A	N/A	DWS Contrast?	N/A
N/A	Landing Slope (%)	N/A	N/A	DWS Length (in)	N/A
N/A	Landing X Slope (%)	N/A	N/A	DWS Full Width?	N/A
N/A	Landing Curb? (Y/N)	N/A	N/A	DWS Offset (in)	N/A
N/A	Shared Landing?	N/A			
N/A	Gutter Ponding?	N/A	N/A	Gutter Slope (%)	N/A
N/A	Gutter Lip Ht (in)	N/A	N/A	Gutter X Slope (%)	N/A
N/A	Painted X Walk1?	No	N/A	Painted X Walk2?	N/A
	X Walk 1 Direction	To W		X Walk 2 Direction	N/A
N/A	X Walk 1 Width (in)	N/A	N/A	X Walk 2 Width (in)	N/A
	X Walk 1 Slope (%)	4.3		X Walk 2 Slope (%)	N/A
	X Walk 1 X Slope (%)	2.1		X Walk 2 X Slope (%)	N/A

N/A	Ramp inside XWalk1?	N/A	N/A	Ramp inside XWalk2?	N/A
	Road Slope (%)	N/A	N/A	Clear Space?	N/A
	Road X Slope (%)	N/A	N/A	Clear Space to XWalk (in)	N/A
N/A	Any Obstructions?	N/A	N/A	Storm Grate/Utility Hazard?	N/A
	Obstruction Type			Storm Grate/Utility Type	
		N/A			N/A
			Yes	Surface Condition? (G/P)	Good

Remove & Replace Entire Ramp.
