Access Compliance Report

Public Rights-of-Way

(Curb Ramps)

Intersection ID: 10619	Main Street: MARTIN_ST	Cross Street: W_5TH_ST	Location:	N
ADA ID: 1D25FA26C346	Ramp Type: Perp	Initial Pass/Fail: Fail	Overall Compliance: No	Severity Score: 8.75
Codes/Mitigation Info/Possible Solution		Field Measurements/Component Compliance

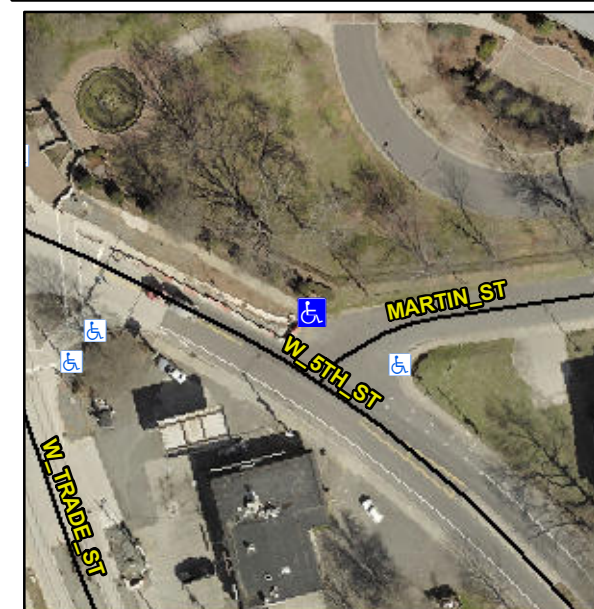
Not Found, R304.5.1

Compliance	Description	Data	Compliance	Description	Data
N/A	Ramp Length (in)	61.0	Yes	Ramp Slope (%)	7.4
No	Ramp Width (in)	42.0	Yes	Ramp XSlope (%)	1.8
N/A	Flare Type LT	N/A	N/A	Flare Type RT	N/A
N/A	Flare Slope LT (%)	N/A	N/A	Flare Slope RT (%)	N/A
N/A	Flare Traversable LT?	N/A	N/A	Flare Traversable RT?	N/A
N/A	Landing Length (in)	N/A	N/A	DWS Provided?	N/A
N/A	Landing Width (in)	N/A	N/A	DWS Contrast?	N/A
N/A	Landing Slope (%)	N/A	N/A	DWS Length (in)	N/A
N/A	Landing X Slope (%)	N/A	N/A	DWS Full Width?	N/A
N/A	Landing Curb? (Y/N)	N/A	N/A	DWS Offset (in)	N/A
N/A	Shared Landing?	N/A			
N/A	Gutter Ponding?	N/A	N/A	Gutter Slope (%)	N/A
N/A	Gutter Lip Ht (in)	N/A	N/A	Gutter X Slope (%)	N/A
N/A	Painted X Walk1?	No	N/A	Painted X Walk2?	N/A
	X Walk 1 Direction	To SE		X Walk 2 Direction	N/A
N/A	X Walk 1 Width (in)	N/A	N/A	X Walk 2 Width (in)	N/A
	X Walk 1 Slope (%)	0.4		X Walk 2 Slope (%)	N/A
	X Walk 1 X Slope (%)	4.8		X Walk 2 X Slope (%)	N/A

N/A	Ramp inside XWalk1?	N/A	N/A	Ramp inside XWalk2?	N/A
	Road Slope (%)	N/A	N/A	Clear Space?	N/A
	Road X Slope (%)	N/A	N/A	Clear Space to XWalk (in)	N/A
N/A	Any Obstructions?	N/A	N/A	Storm Grate/Utility Hazard?	N/A
	Obstruction Type			Storm Grate/Utility Type	
		N/A			N/A
			Yes	Surface Condition? (G/P)	Good

Possible Solutions:

Remove & Replace Entire Ramp.

Total Cost: \$ 1850.00
