# Access Compliance Report

## Public Rights-of-Way

### (Curb Ramps)

| Intersection ID: 27490 | Main Street: BALLANTYNE_COMMONS_PY | Cross Street: JOHNSTON_RD | Location: SE |

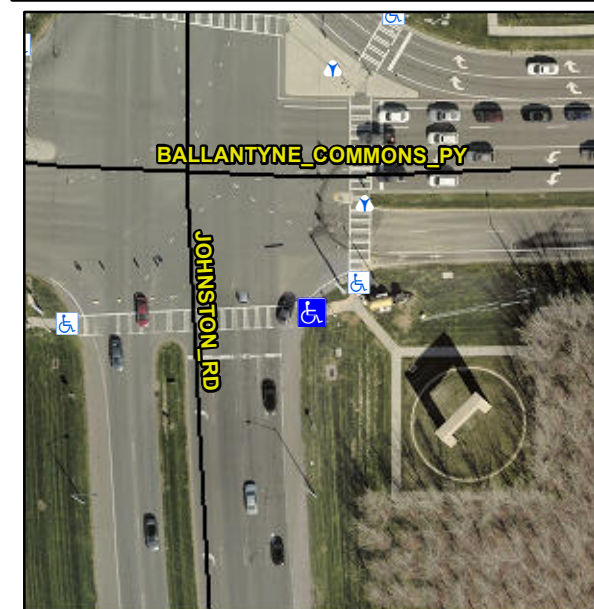
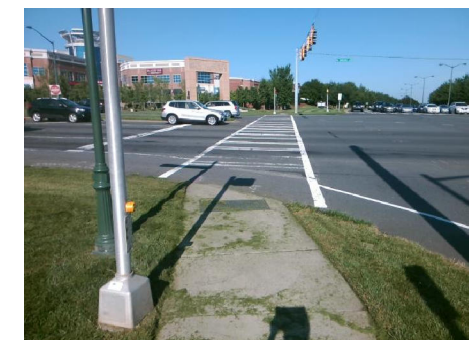
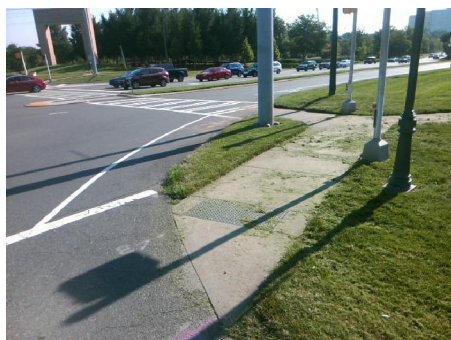
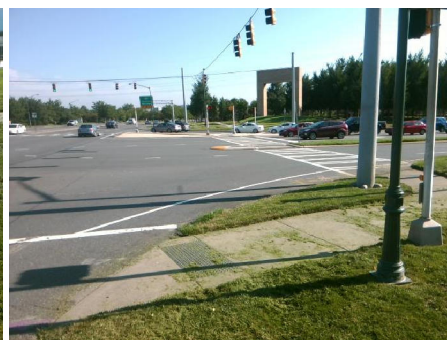
**NO CURB LINE**

**R304.2.2-Perp, R304.3.2-Para,  
R304.5.2, R305.2, R304.5.3**

| Compliance | Description | Data | Compliance | Description | Data |
|---|---|---|---|---|---|
| No | Landing Slope (%) | 2.9 | Yes | DWS Length (in) | 24.5 |
| Yes | Gutter Lip Ht (in) | 0.0 | No | Gutter X Slope (%) | 5.8 |

**Remove & Replace Entire Ramp.  
Remove & Replace Gutter.**
