# Access Compliance Report

## Public Rights-of-Way

### (Curb Ramps)

| Intersection ID: 44304 | Main Street: KIEV_DR | Cross Street: MALLORY_TAYLOR_LN | Location: SW |

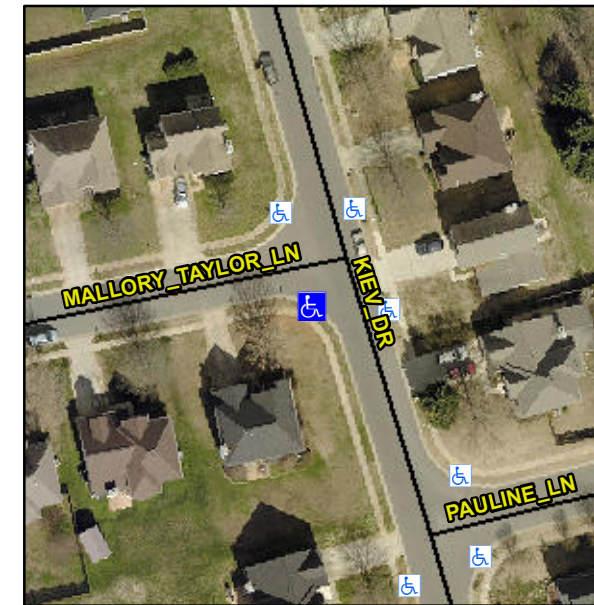
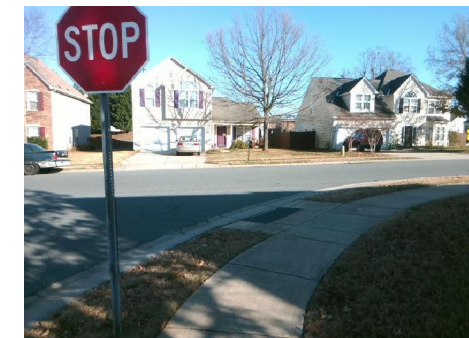
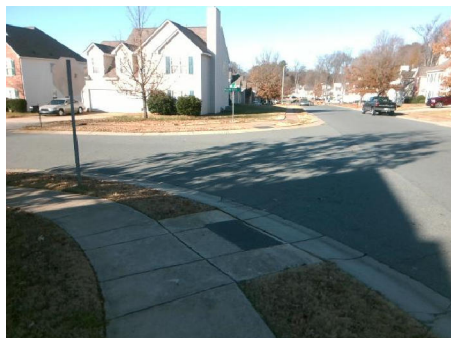
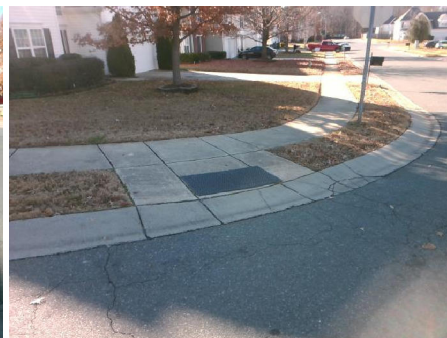
| ADA ID: 1D4E71DA200A | Ramp Type: PerpDiag | Initial Pass/Fail: Fail | Overall Compliance: No |

**Not Found, R304.5.1, R304.5.3**

| Compliance | Description | Data | Compliance | Description | Data |
|---|---|---|---|---|---|
| N/A | Ramp Length (in) | 48.5 | Yes | Ramp Slope (%) | 7.1 |
| No | Ramp Width (in) | 42.0 | No | Ramp XSlope (%) | 9.8 |

**Remove & Replace Curb Ramp With Two New Directional Ramps or Equivalent.**
