# Access Compliance Report

## Public Rights-of-Way

| Intersection ID: 14661 | Main Street: E_TREMONT_AV | Cross Street: WINTHROP_AV | Location: W |
| ADA ID: 1D523369260F | Ramp Type: Directional1 | Initial Pass/Fail: Pass | Overall Compliance: No |

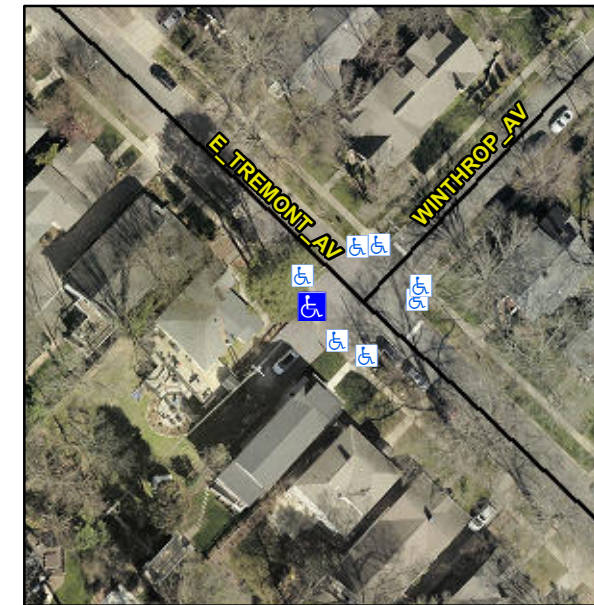
| | | Severity Score: 20 | |

**R304.2.2-Perp, R304.3.2-Para,  
R304.2.3, R305.1.4, R302.7.2,  
R304.5.3**

| Compliance | Description | Data | Compliance | Description | Data |
|---|---|---|---|---|---|
| N/A | Flare Slope LT (%) | 8.9 | No | Flare Slope RT (%) | 10.8 |
| No | Landing Slope (%) | 3.0 | Yes | DWS Length (in) | 24.5 |
| Yes | Landing X Slope (%) | 1.5 | No | DWS Full Width? | No |

Possible Solutions:

**Remove & Replace Entire Ramp.  
Remove & Replace Gutter.**

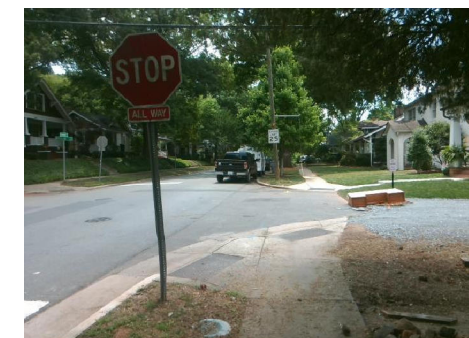
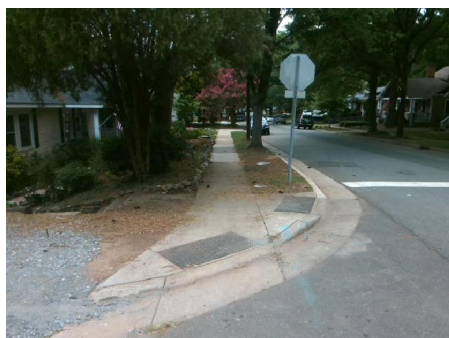
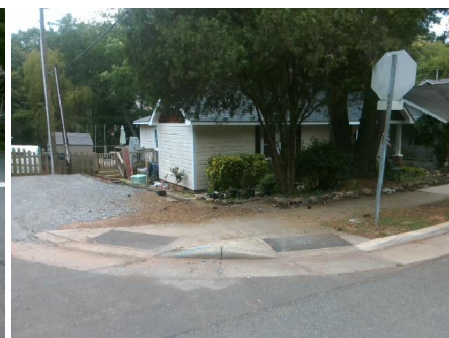
| Compliance | Description | Data | Compliance | Description | Data |
|---|---|---|---|---|---|
| No | Gutter Lip Ht (in) | 1.0 | No | Gutter X Slope (%) | 3.6 |
