Access Compliance Report

Public Rights-of-Way

(Curb Ramps)

Intersection ID: 10040845	Main Street: WAKEFIELD_DR	Cross Street: N/A	Location: NW
ADA ID: 1D52E2D3F6F0	Ramp Type: PerpDiag	Initial Pass/Fail: Fail	Overall Compliance: No Severity Score: 13.75

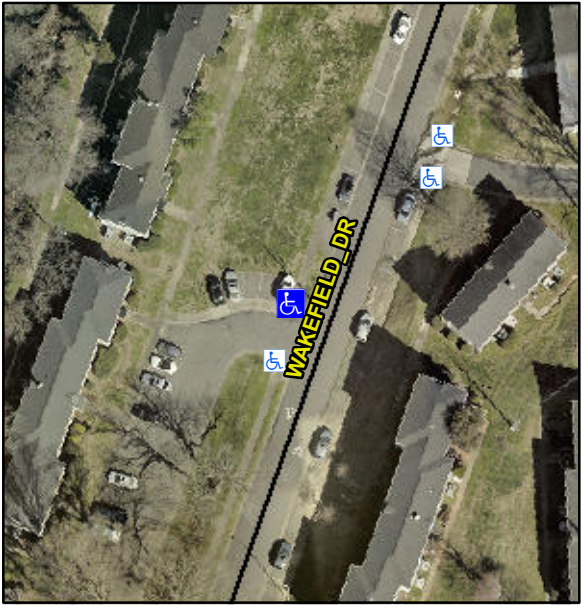
Possible Solutions:		Compliance	Description	Data
	Remove & Replace Curb Ramp With Two New Directional Ramps or Equivalent.		N/A	Ramp Length (in)	49.0
			Yes	Ramp Width (in)	55.0
			N/A	Flare Type LT	N/A
			N/A	Flare Slope LT (%)	N/A
			N/A	Flare Traversable LT?	N/A
			N/A	Landing Length (in)	N/A
			N/A	Landing Width (in)	N/A
			N/A	Landing Slope (%)	N/A
			N/A	Landing X Slope (%)	N/A
			N/A	Landing Curb? (Y/N)	N/A
			N/A	Shared Landing?	N/A
			N/A	Gutter Ponding?	N/A
			N/A	Gutter Lip Ht (in)	N/A
			N/A	Painted X Walk1?	No
				X Walk 1 Direction	To SW
			N/A	X Walk 1 Width (in)	N/A
				X Walk 1 Slope (%)	2.4
				X Walk 1 X Slope (%)	4.2
			N/A	Ramp inside XWalk1?	N/A
<p>Surveyor Notes:</p> <p>N/A</p> <p>PROW/ADA:</p> <p>Not Found, R304.2.2</p>			N/A	Flare Type RT	N/A
			N/A	Flare Slope RT (%)	N/A
			N/A	Flare Traversable RT?	N/A

N/A	DWS Provided?	N/A
			N/A	DWS Contrast?	N/A
			N/A	DWS Length (in)	N/A
			N/A	DWS Full Width?	N/A
			N/A	DWS Offset (in)	N/A
			N/A	Gutter Slope (%)	N/A
			N/A	Gutter X Slope (%)	N/A
			N/A	Painted X Walk2?	No
				X Walk 2 Direction	To E
			N/A	X Walk 2 Width (in)	N/A
				X Walk 2 Slope (%)	7.0
				X Walk 2 X Slope (%)	2.7
			N/A	Ramp inside XWalk2?	N/A
			N/A	Clear Space?	N/A
			N/A	Clear Space to XWalk (in)	N/A
			N/A	Storm Grate/Utility Hazard?	N/A
				Storm Grate/Utility Type	
			N/A		N/A
			Yes	Surface Condition? (G/P)	Good
Street 1 Name	ENTRANCE				
Stop Condition-Street 2	None				
Street 2 Name	WAKEFIELD DR				
Stop Condition-Street 1	None				
Total Cost:	\$	3200.00
