Access Compliance Report

Public Rights-of-Way

(Curb Ramps)

Intersection ID: 10018381	Main Street: PADSTOW_CT	Cross Street: N/A	Location: NE
ADA ID: 1D577FC0C7B5	Ramp Type: Perp	Initial Pass/Fail: Fail	Overall Compliance: No
Severity Score: 8.75			
Codes/Mitigation Info/Possible Solution		Field Measurements/Component Compliance

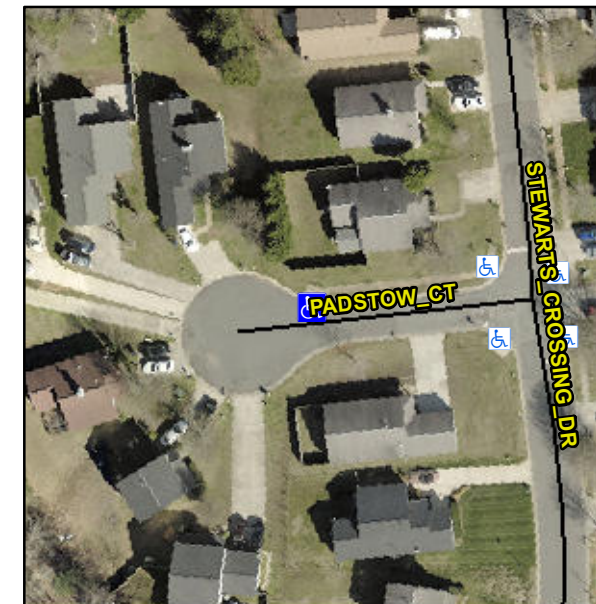
Not Found, R304.5.1

Compliance	Description	Data	Compliance	Description	Data
N/A	Ramp Length (in)	32.0	Yes	Ramp Slope (%)	8.3
No	Ramp Width (in)	47.0	Yes	Ramp XSlope (%)	0.3
N/A	Flare Type LT	N/A	N/A	Flare Type RT	N/A
N/A	Flare Slope LT (%)	N/A	N/A	Flare Slope RT (%)	N/A
N/A	Flare Traversable LT?	N/A	N/A	Flare Traversable RT?	N/A
N/A	Landing Length (in)	N/A	N/A	DWS Provided?	N/A
N/A	Landing Width (in)	N/A	N/A	DWS Contrast?	N/A
N/A	Landing Slope (%)	N/A	N/A	DWS Length (in)	N/A
N/A	Landing X Slope (%)	N/A	N/A	DWS Full Width?	N/A
N/A	Landing Curb? (Y/N)	N/A	N/A	DWS Offset (in)	N/A
N/A	Shared Landing?	N/A			
N/A	Gutter Ponding?	N/A	N/A	Gutter Slope (%)	N/A
N/A	Gutter Lip Ht (in)	N/A	N/A	Gutter X Slope (%)	N/A
N/A	Painted X Walk1?	No	N/A	Painted X Walk2?	N/A
	X Walk 1 Direction	To S		X Walk 2 Direction	N/A
N/A	X Walk 1 Width (in)	N/A	N/A	X Walk 2 Width (in)	N/A
	X Walk 1 Slope (%)	3.6		X Walk 2 Slope (%)	N/A
	X Walk 1 X Slope (%)	1.0		X Walk 2 X Slope (%)	N/A

N/A	Ramp inside XWalk1?	N/A	N/A	Ramp inside XWalk2?	N/A
	Road Slope (%)	N/A	N/A	Clear Space?	N/A
	Road X Slope (%)	N/A	N/A	Clear Space to XWalk (in)	N/A
N/A	Any Obstructions?	N/A	N/A	Storm Grate/Utility Hazard?	N/A
	Obstruction Type			Storm Grate/Utility Type	
		N/A			N/A
			Yes	Surface Condition? (G/P)	Good

Remove & Replace Entire Ramp.
