# Access Compliance Report

## Public Rights-of-Way

### (Curb Ramps)

Intersection ID: 10910	Main Street: N_SUMMIT_AV	Cross Street: W_5TH_ST	Location: E
ADA ID: 1D5CC50A7495	Ramp Type: BlendTrans1	Initial Pass/Fail: Fail	Overall Compliance: No
		Severity Score: 10

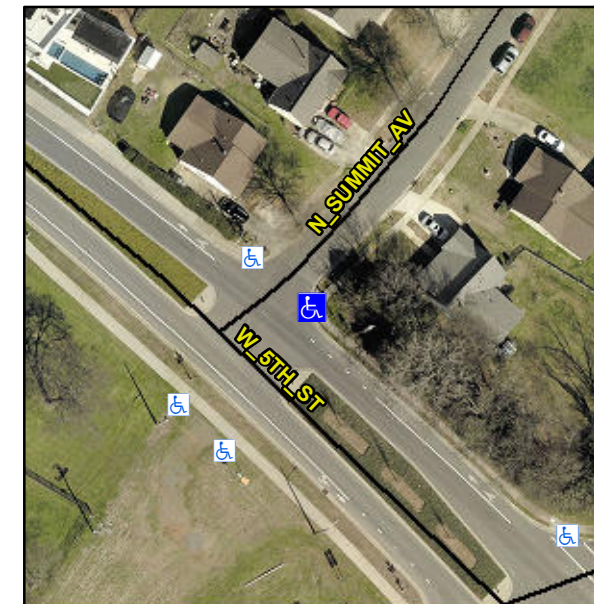
Compliance	Description	Data	Compliance	Description	Data
N/A	Ramp Length (in)	77.0	Yes	BlendTrans Slope (%)	3.9
No	Ramp Width (in)	47.5	No	BlendTrans XSlope (%)	2.5
N/A	Flare Type LT	N/A	N/A	Flare Type RT	N/A
N/A	Flare Slope LT (%)	N/A	N/A	Flare Slope RT (%)	N/A
N/A	Flare Traversable LT?	N/A	N/A	Flare Traversable RT?	N/A
N/A	Landing Length (in)	N/A	N/A	DWS Provided?	N/A
N/A	Landing Width (in)	N/A	N/A	DWS Contrast?	N/A
N/A	Landing Slope (%)	N/A	N/A	DWS Length (in)	N/A
N/A	Landing X Slope (%)	N/A	N/A	DWS Full Width?	N/A
N/A	Landing Curb? (Y/N)	N/A	N/A	DWS Offset (in)	N/A
N/A	Shared Landing?	N/A			
N/A	Gutter Ponding?	N/A	N/A	Gutter Slope (%)	N/A
N/A	Gutter Lip Ht (in)	N/A	N/A	Gutter X Slope (%)	N/A
N/A	Painted X Walk1?	No	N/A	Painted X Walk2?	No
	X Walk 1 Direction	To NW		X Walk 2 Direction	To SW
	X Walk 1 Width (in)	N/A		X Walk 2 Width (in)	N/A
	X Walk 1 Slope (%)	7.4		X Walk 2 Slope (%)	6.8
	X Walk 1 X Slope (%)	1.4		X Walk 2 X Slope (%)	6.1

N/A	Ramp inside XWalk1?	N/A	N/A	Ramp inside XWalk2?	N/A
	Road Slope (%)	0.6		Clear Space?	N/A
	Road X Slope (%)	8.4	N/A	Clear Space to XWalk (in)	N/A
N/A	Any Obstructions?	N/A	N/A	Storm Grate/Utility Hazard?	N/A
	Obstruction Type			Storm Grate/Utility Type	
		N/A			N/A
			Yes	Surface Condition? (G/P)	Good
			No	Curb Slope (%)	14.9

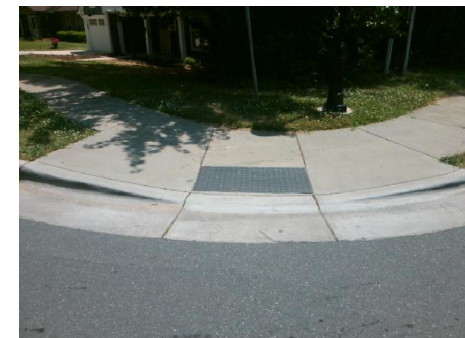
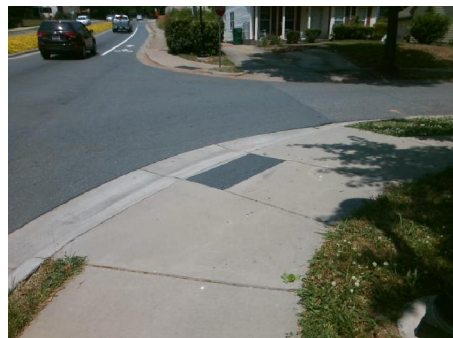
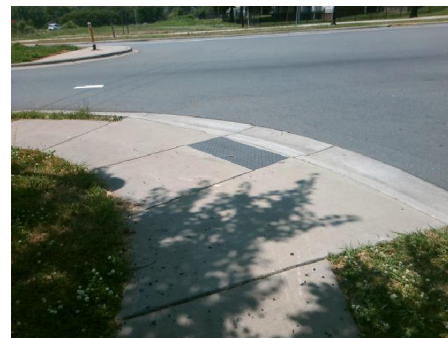
**Not Found, R304.5.1, R304.5.3**

**Remove & Replace Curb Ramp With Two New Directional Ramps or Equivalent.**
